## ICOM M802

## COLEMAN POWERCHILL 40

## GARMIN RECALL

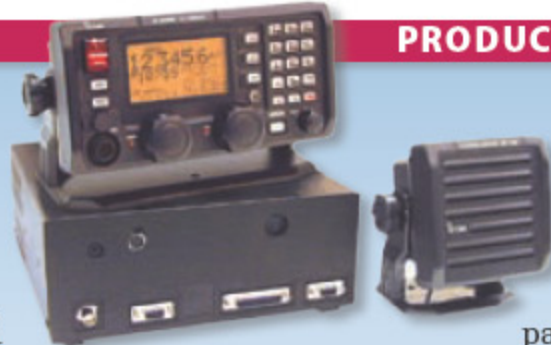
*Icom M802*

On affected M802s, on certain voice patterns, the receiving party may hear only part of a word, and then the transmission quickly comes back. The operator may hear a few more words and then the voice would cut-out again.

According to Icom, this occurs when the radio's antenna is generating a standing wave ratio (SWR)—the ratio of maximum power in a wave to minimum power in the wave—of 1.6 or more. While proper installation and maintenance of an antenna system may help reduce SWR, there are antenna situations where the ratio may be higher than 1.6.

Icom's "improvement" to the M802 ensures that the radio will

not "clip," no matter the SWR.

To upgrade your M802, contact Icom's service department at service@

icomamerica.com or 425/454-7619. This improvement will be in all future M802s.
