I Can See Clearly Now

Bob Davie
Starry Messenger, Starflight 38
 Peterborough, Ontario

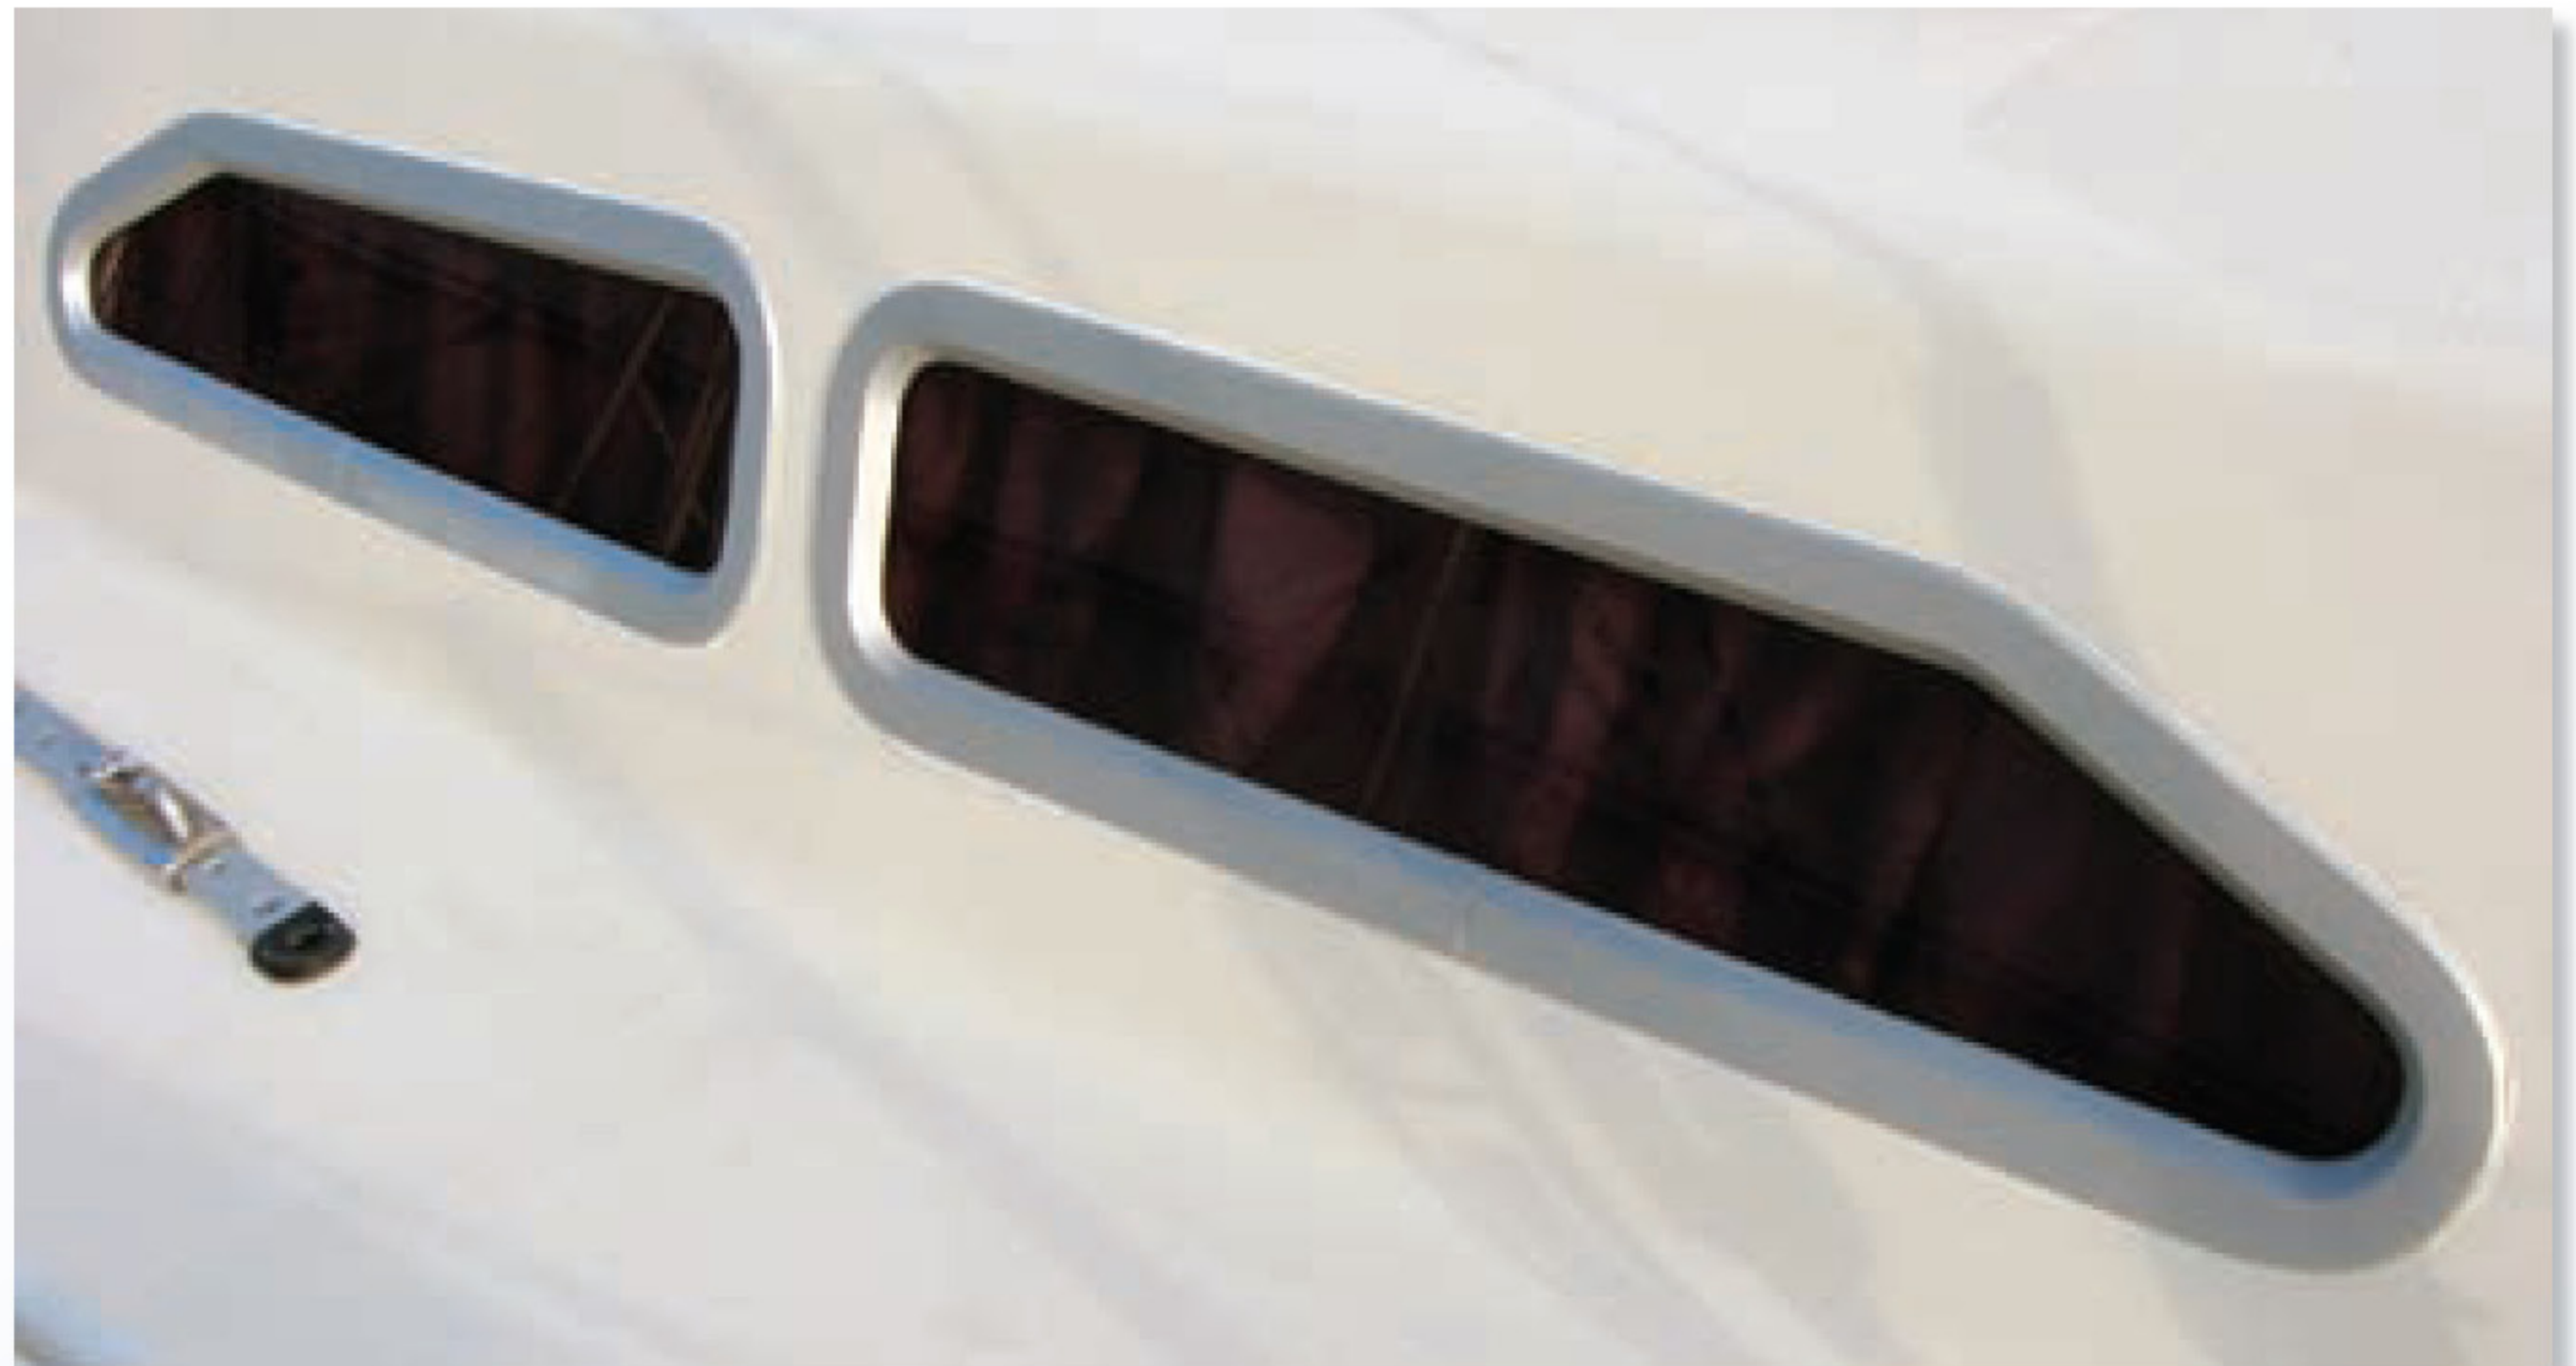
This is the promised follow-up to my letter that was published in the 'PS Advisor' section of the June 2007 issue, "Plagued by Leaky Ports." In January, we concluded that the size of the original leaky port opening was too large for any nonreinforced window to withstand the flexing of the deck caused by the normal loads associated with sailing and haulout/launch. Therefore, in consultation with Larry O'Rourke of O'Rourke Boat Repair, we decided to have the opening glassed in (see photos at right) and a pair of Lewmar size 4 non-opening standard series portlights installed on each side. Another option would have been custom-made windows in aluminum frames, but the Lewmar portlights matched the boat's existing opening ports in both width and appearance.

O'Rourke Boat Repair helped reader Bob Davie solve a leaky port problem on his Starflight 38. They glassed in the cut-outs for the original Lexan windows (bottom photos) and installed Lewmar ports (top photo).

Although the work was considerably more expensive than replacing the existing windows with Lexan, it was worth every penny to have windows that don't leak for the first time in 13 years! Not only is the boat now safer, but we think the new portlights look better, and they let as much light into the cabin as did the windows. An unexpected benefit was that the bilge has gone from being extremely wet to nearly dry. The old windows were letting in much more water than was dripping on the cushions. That water must have been
