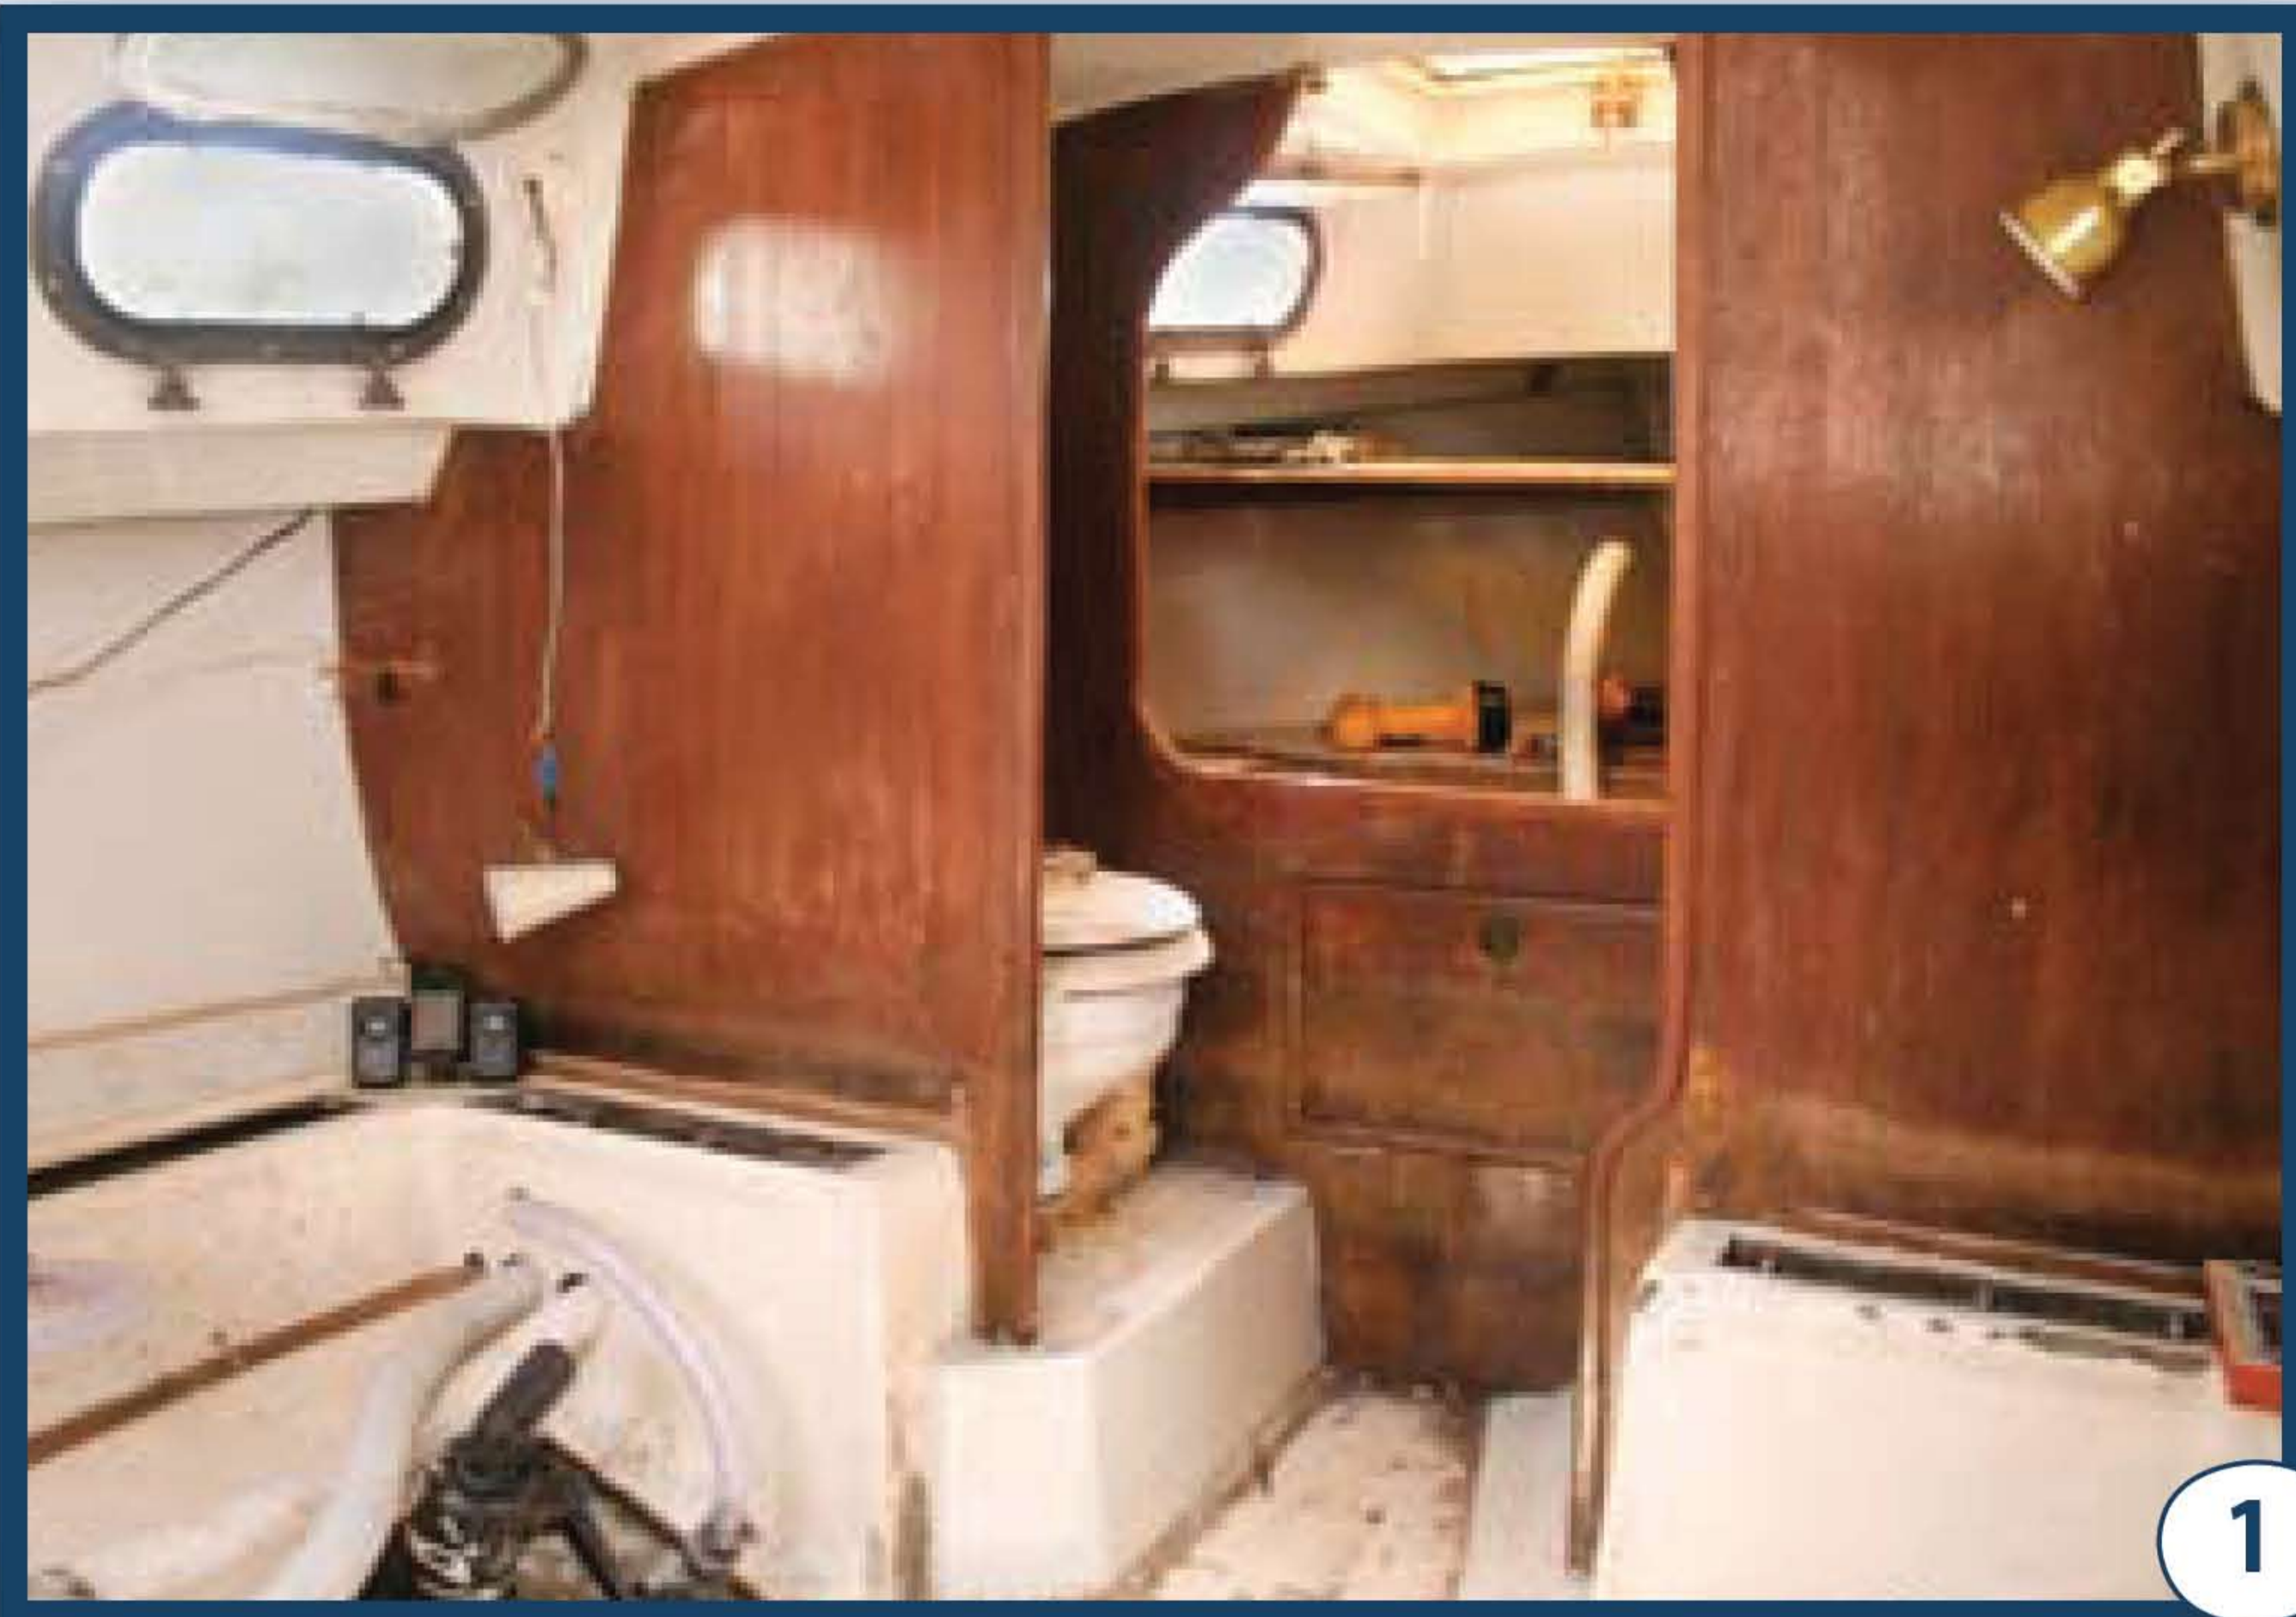
1. The forward view BEFORE; note the water-damaged bulkheads.
2. The forward view AFTER.
3. The head was re-plumbed to comply with California laws. A lockable, two-way Y-valve was added, as were a rigid holding tank, deck pumpout, and an above-the-waterline vented loop.

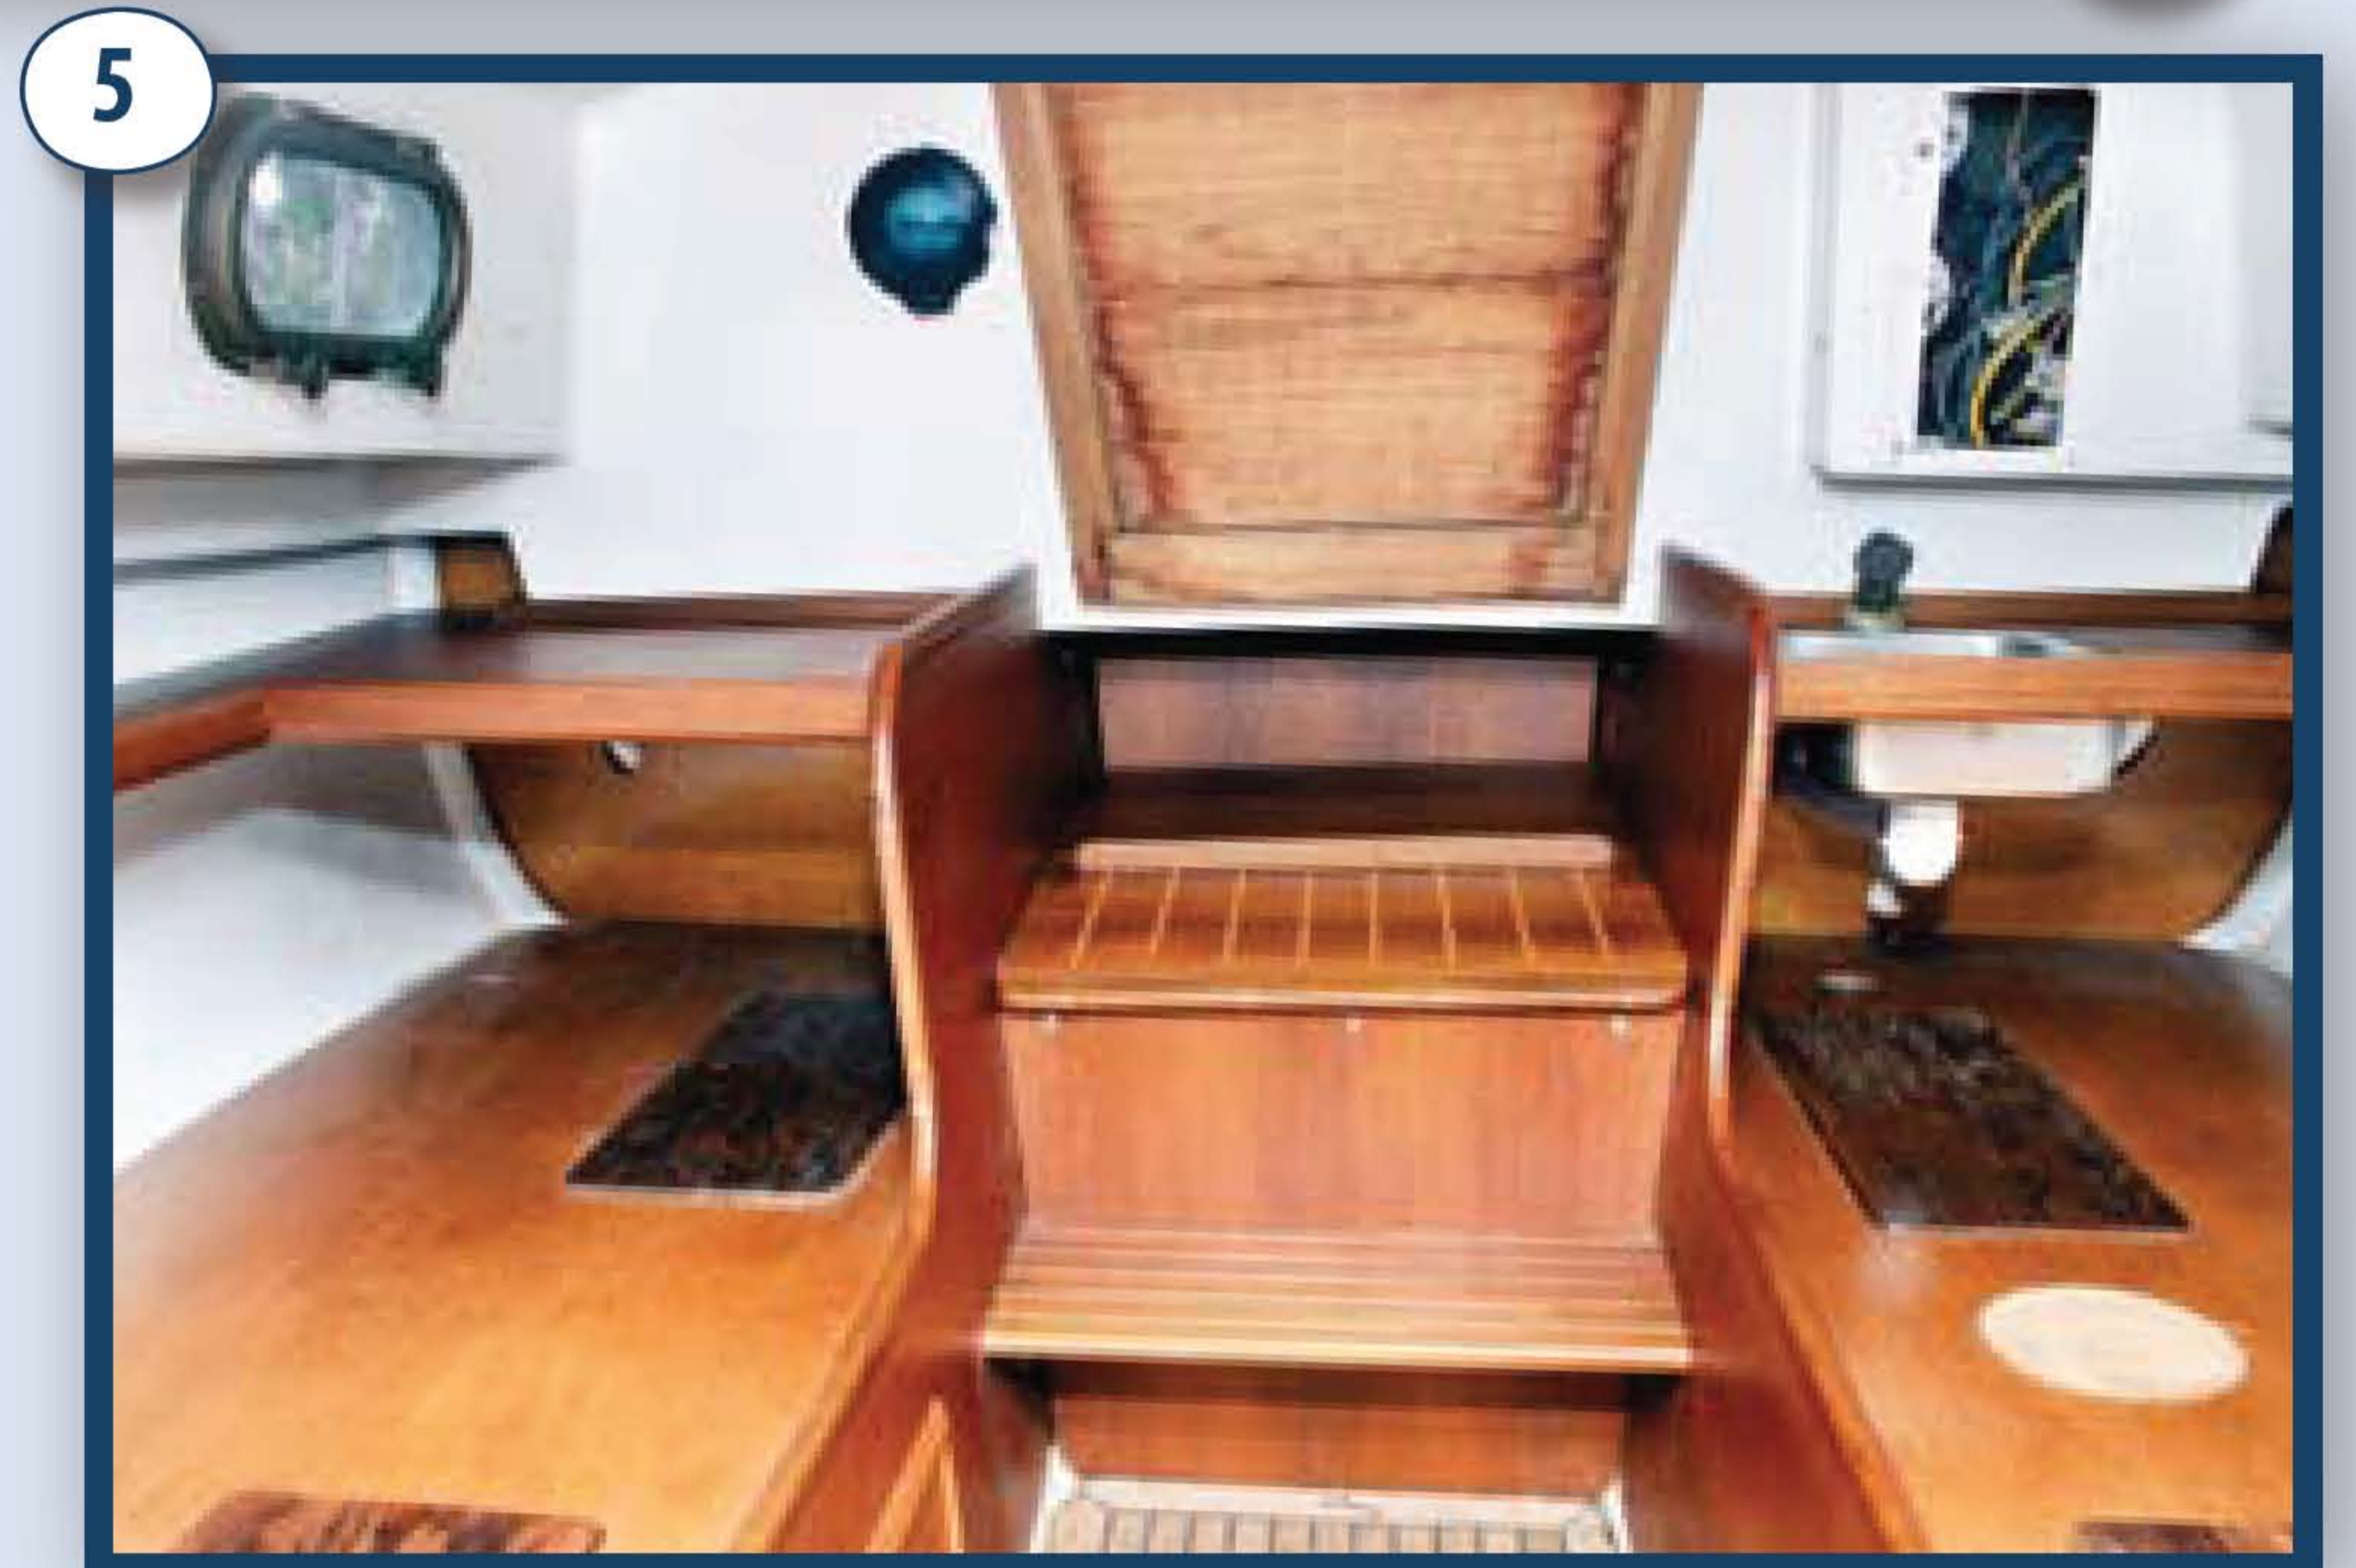
4. The aft view BEFORE.
5. The aft view AFTER. Among the projects still on the to-do list is installing the distribution panel.
6. Our favorite customization: the teak-topped throne.
