BOATBUILDING

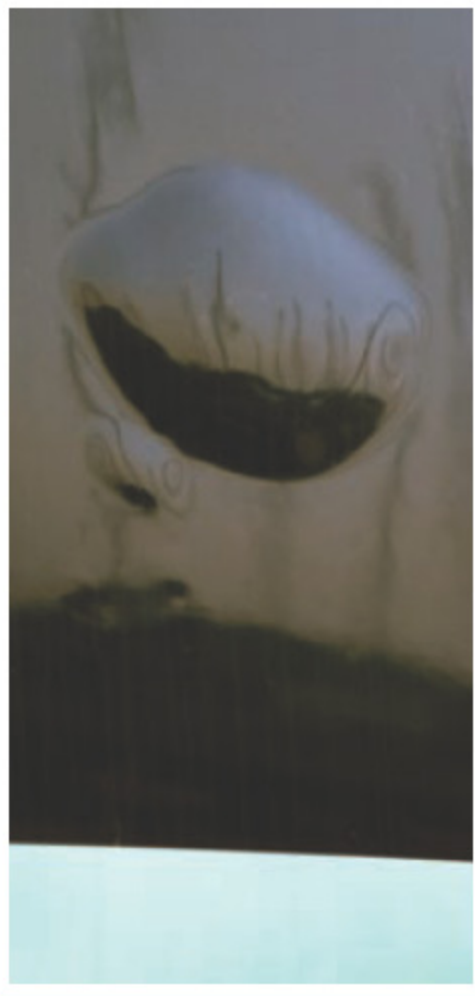
This racing hull exhibited a complete failure of the bond-line between the core and outer skin.

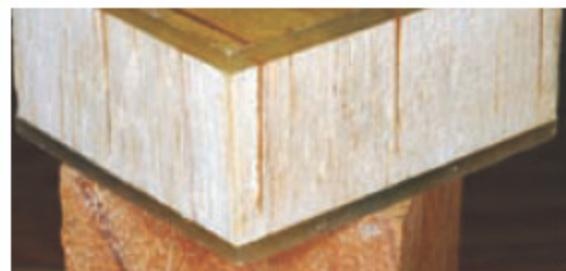
Resin infusion obviously fills the kerfs in the balsa-cored hull of a J-130. The outer surface skin is at the top.

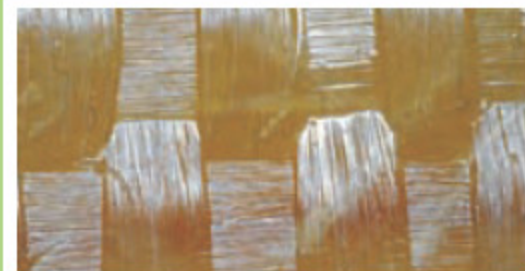
This micro photograph reveals the compression and even saturation of resin-infused woven roven.

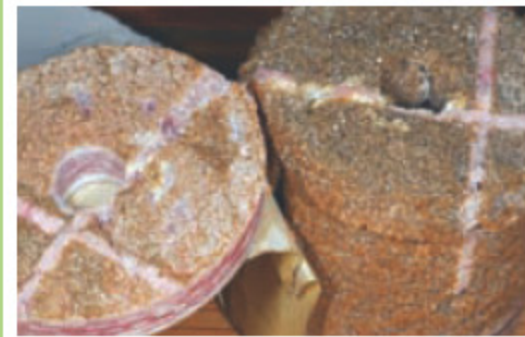
The outer skin has sheared away from the low-density foam core sample, despite good penetration of the core-bond adhesive.

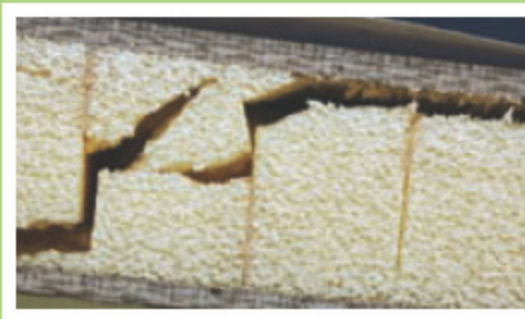
The results of an impact test on a 1-inch-thick cored panel illustrate a classic example of shear failure.

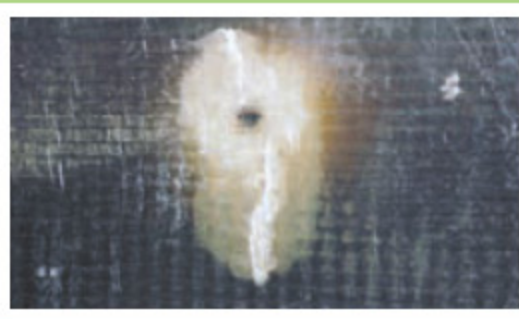
An impact test on a 3/4-inch solid fiberglass panel (shown at right) resulted in this fracture.

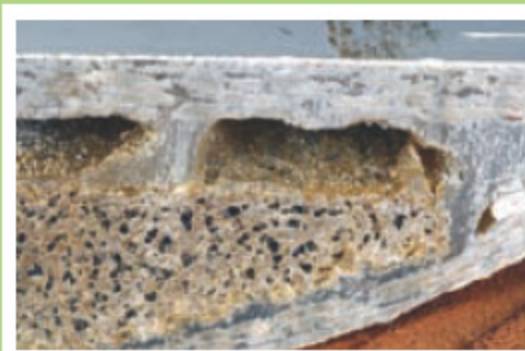
This cross-section of deck laminate shows voids near the outboard edge of the deck where core ends and solid laminate begins.

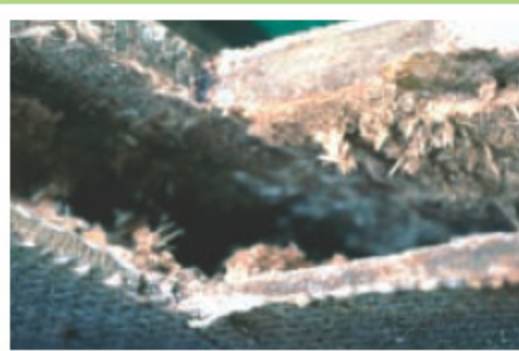
The corner cross-sectional view of a hatch opening shows where rotted core has been reamed out for repair, prior to fitting a new hatch.
