Simplicity of design, and a straightforward approach to construction are two good reasons why the Balboa 26 has been in service for three decades.

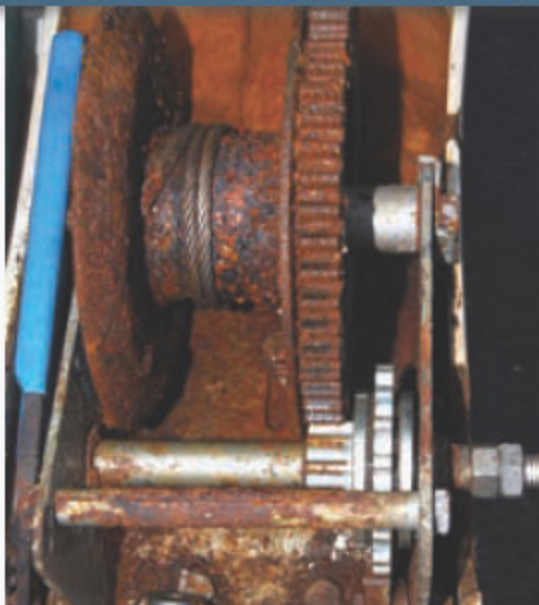
An old trailer winch retrofitted as a swing-keel winch shows its wear.
