The Catamaran Cleat Conundrum

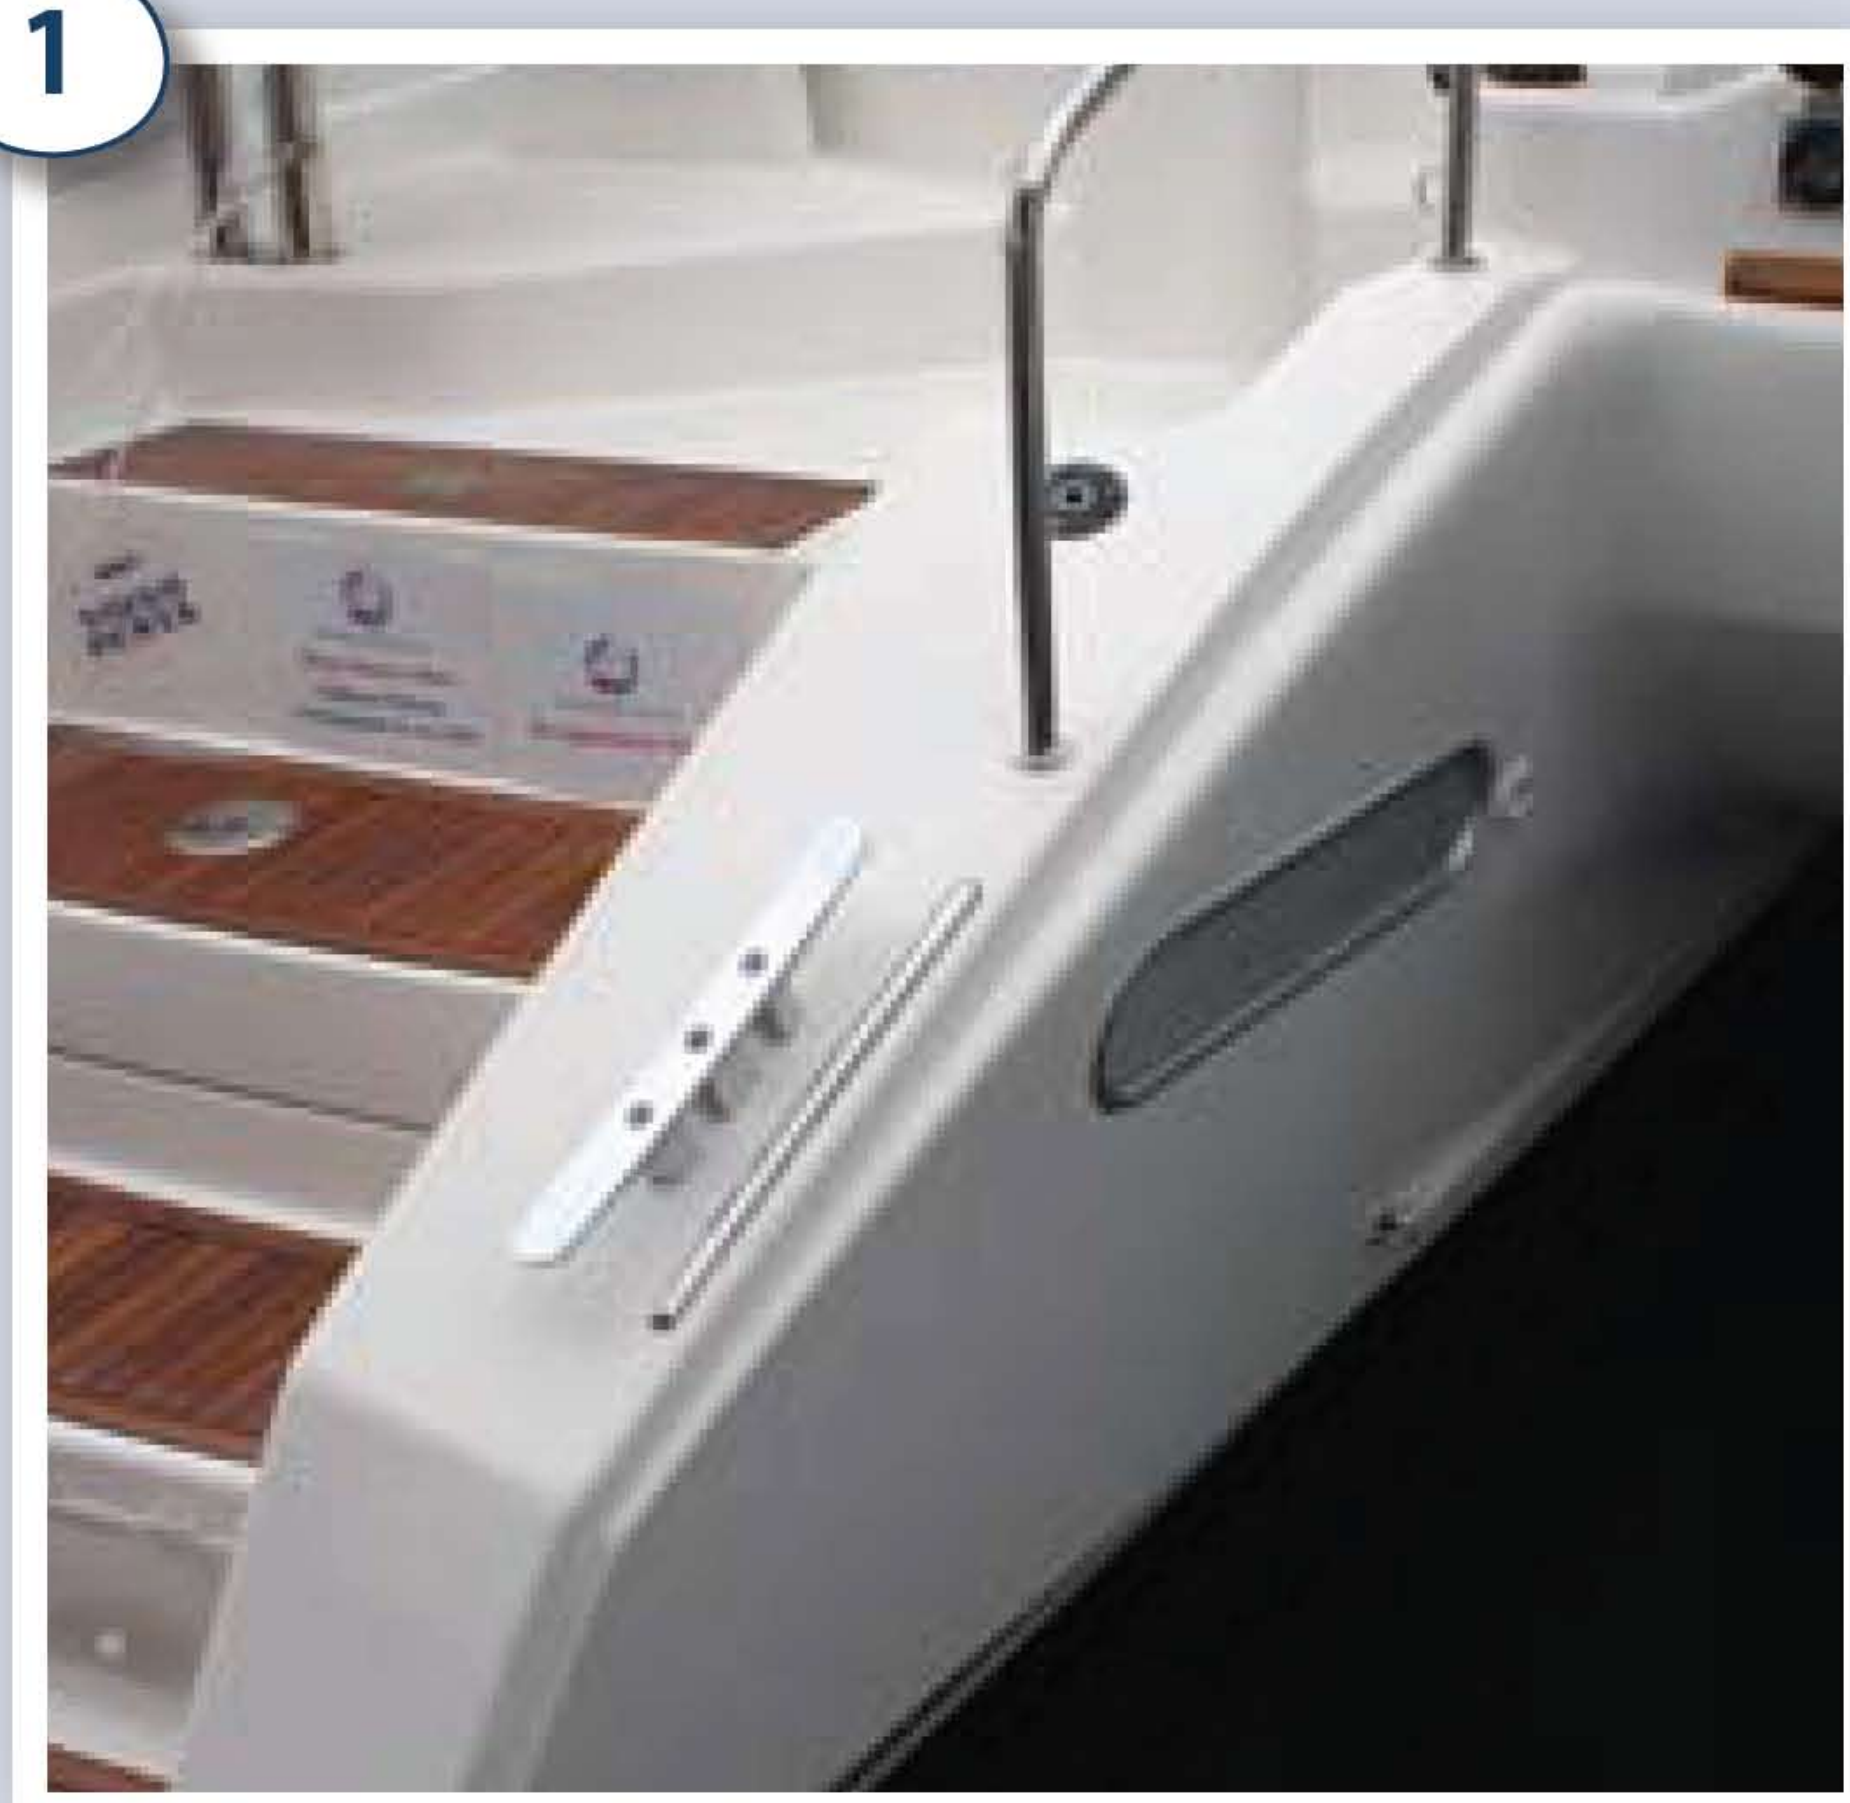
1. Loads on this stern cleat probably won't align with the three-bolt pattern, potentially transferring a tremendous amount of load to the hull skin and backing below. Whether this backing and the bolts can withstand the load is worth considering.

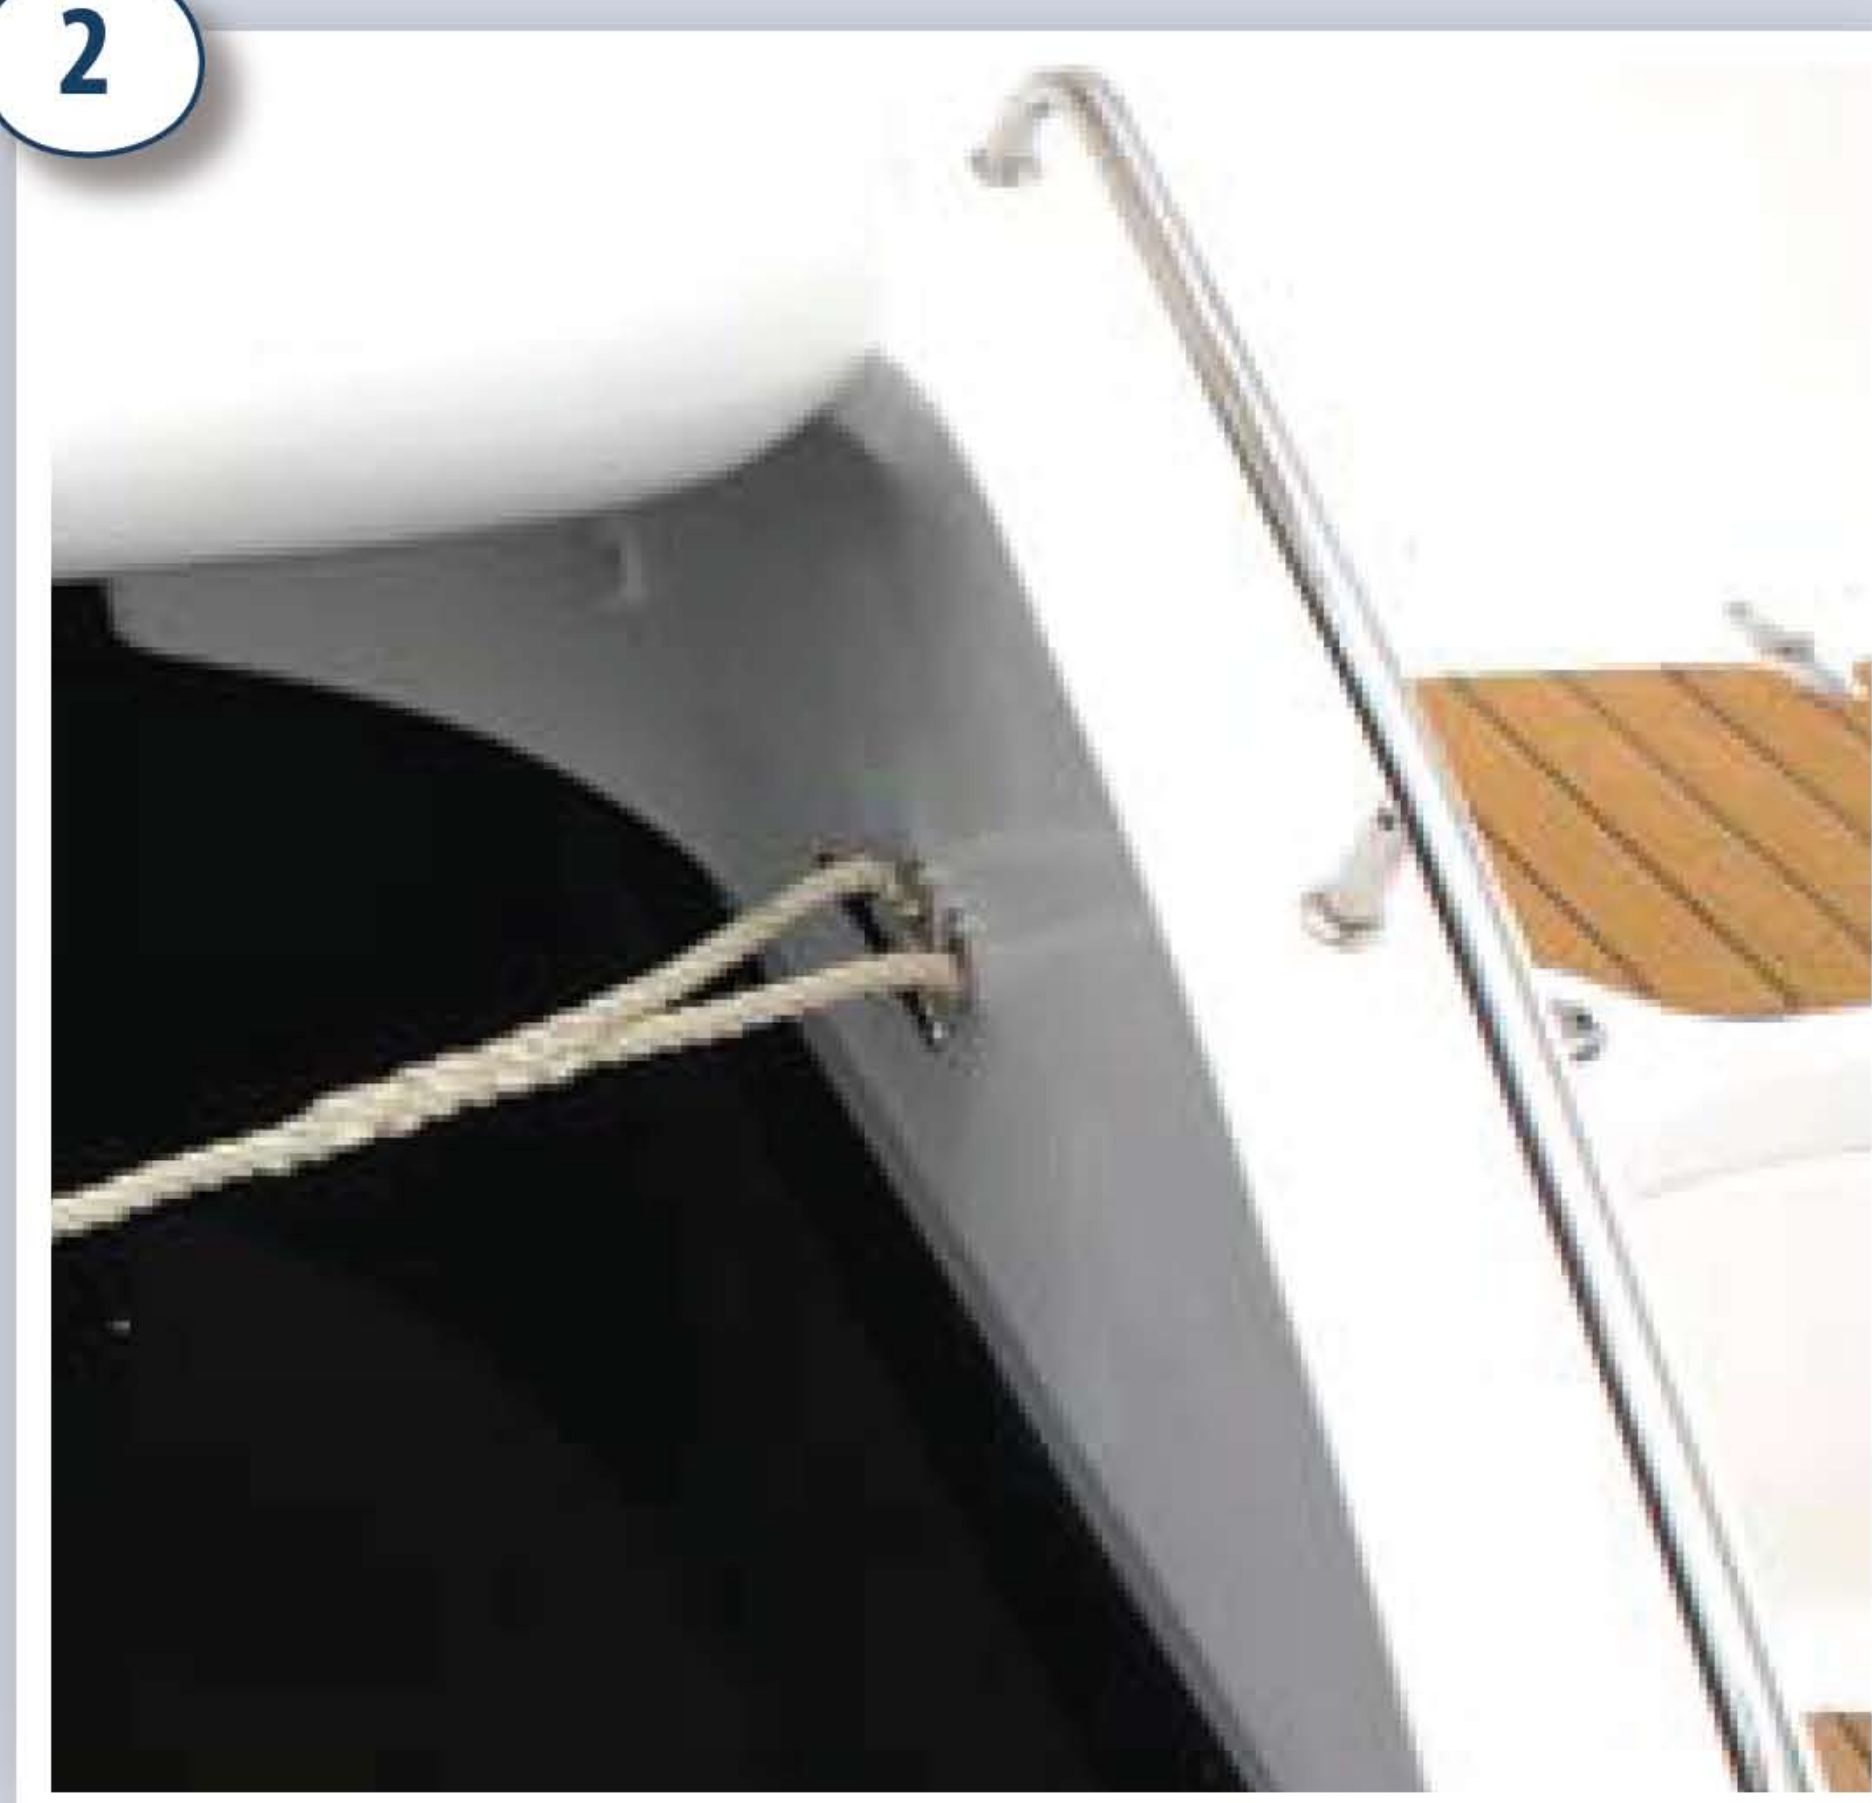
2. Hmm... Without dwelling on the precarious security of this eyesplice, it's clear that this cleat presents several challenges. It is not oriented or placed where it can best distribute the load.

And then there's the bigger question: How is one to handle this line without going swimming?

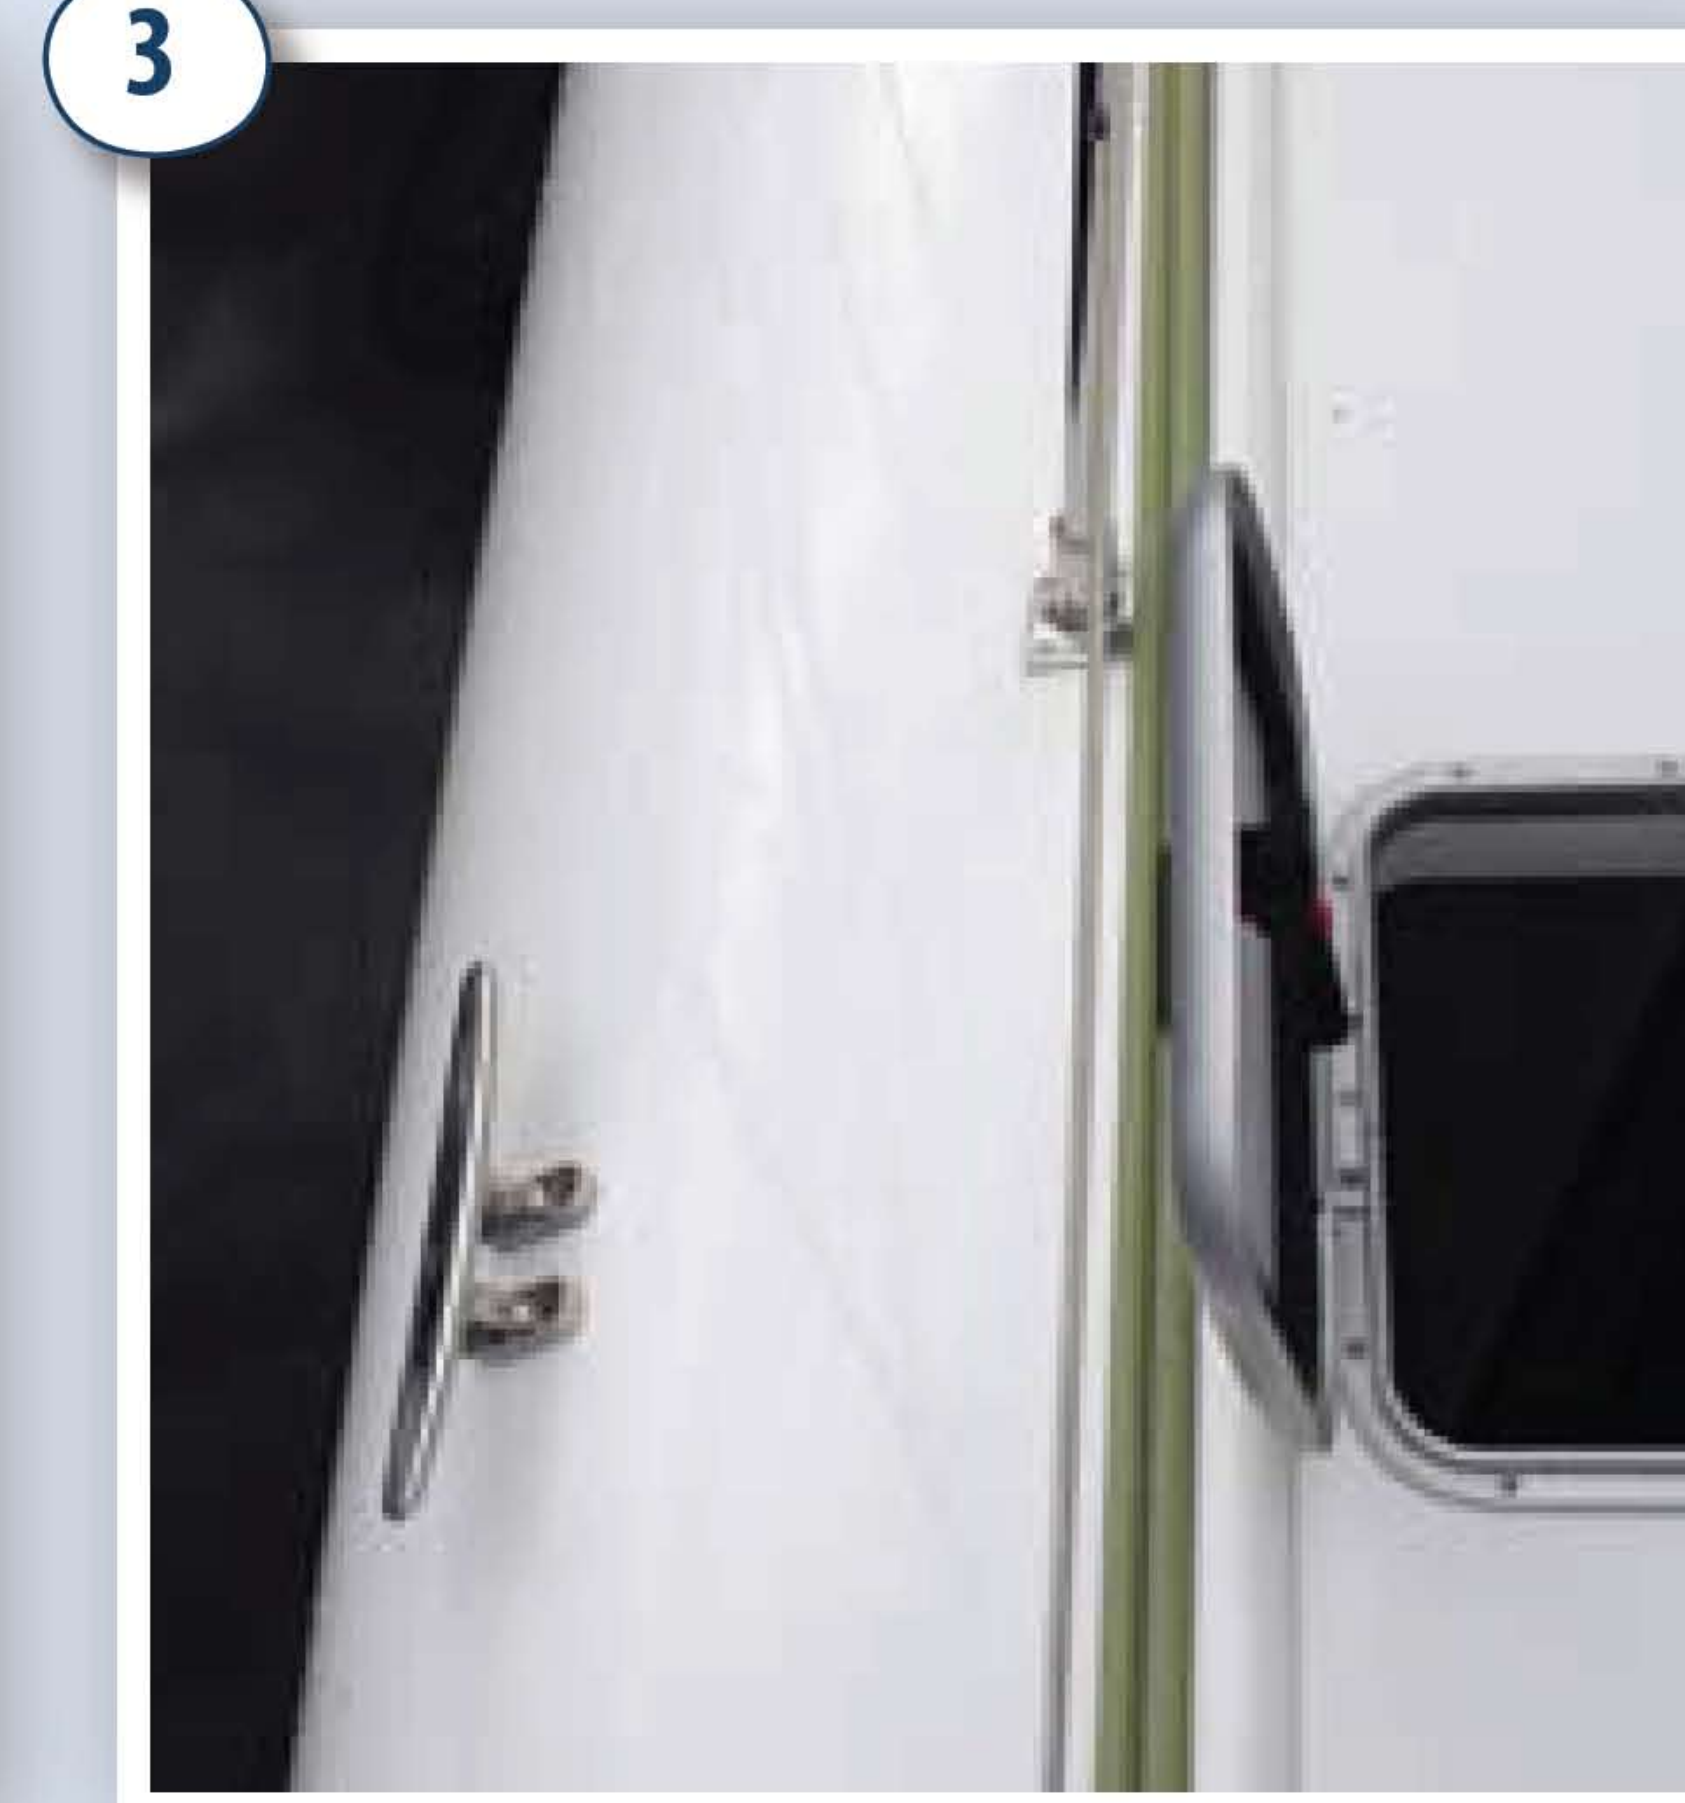
3. Relying on the solid laminate at the hull-to-deck joint to beef up a cleat can raise other issues. Here, the line-handler must lean over or through the lifeline and, hopefully, will restrain the impulse to step on the slick curved deck that leads to the briny below.
