## PS Reader's Letter Sparks Tether Recall

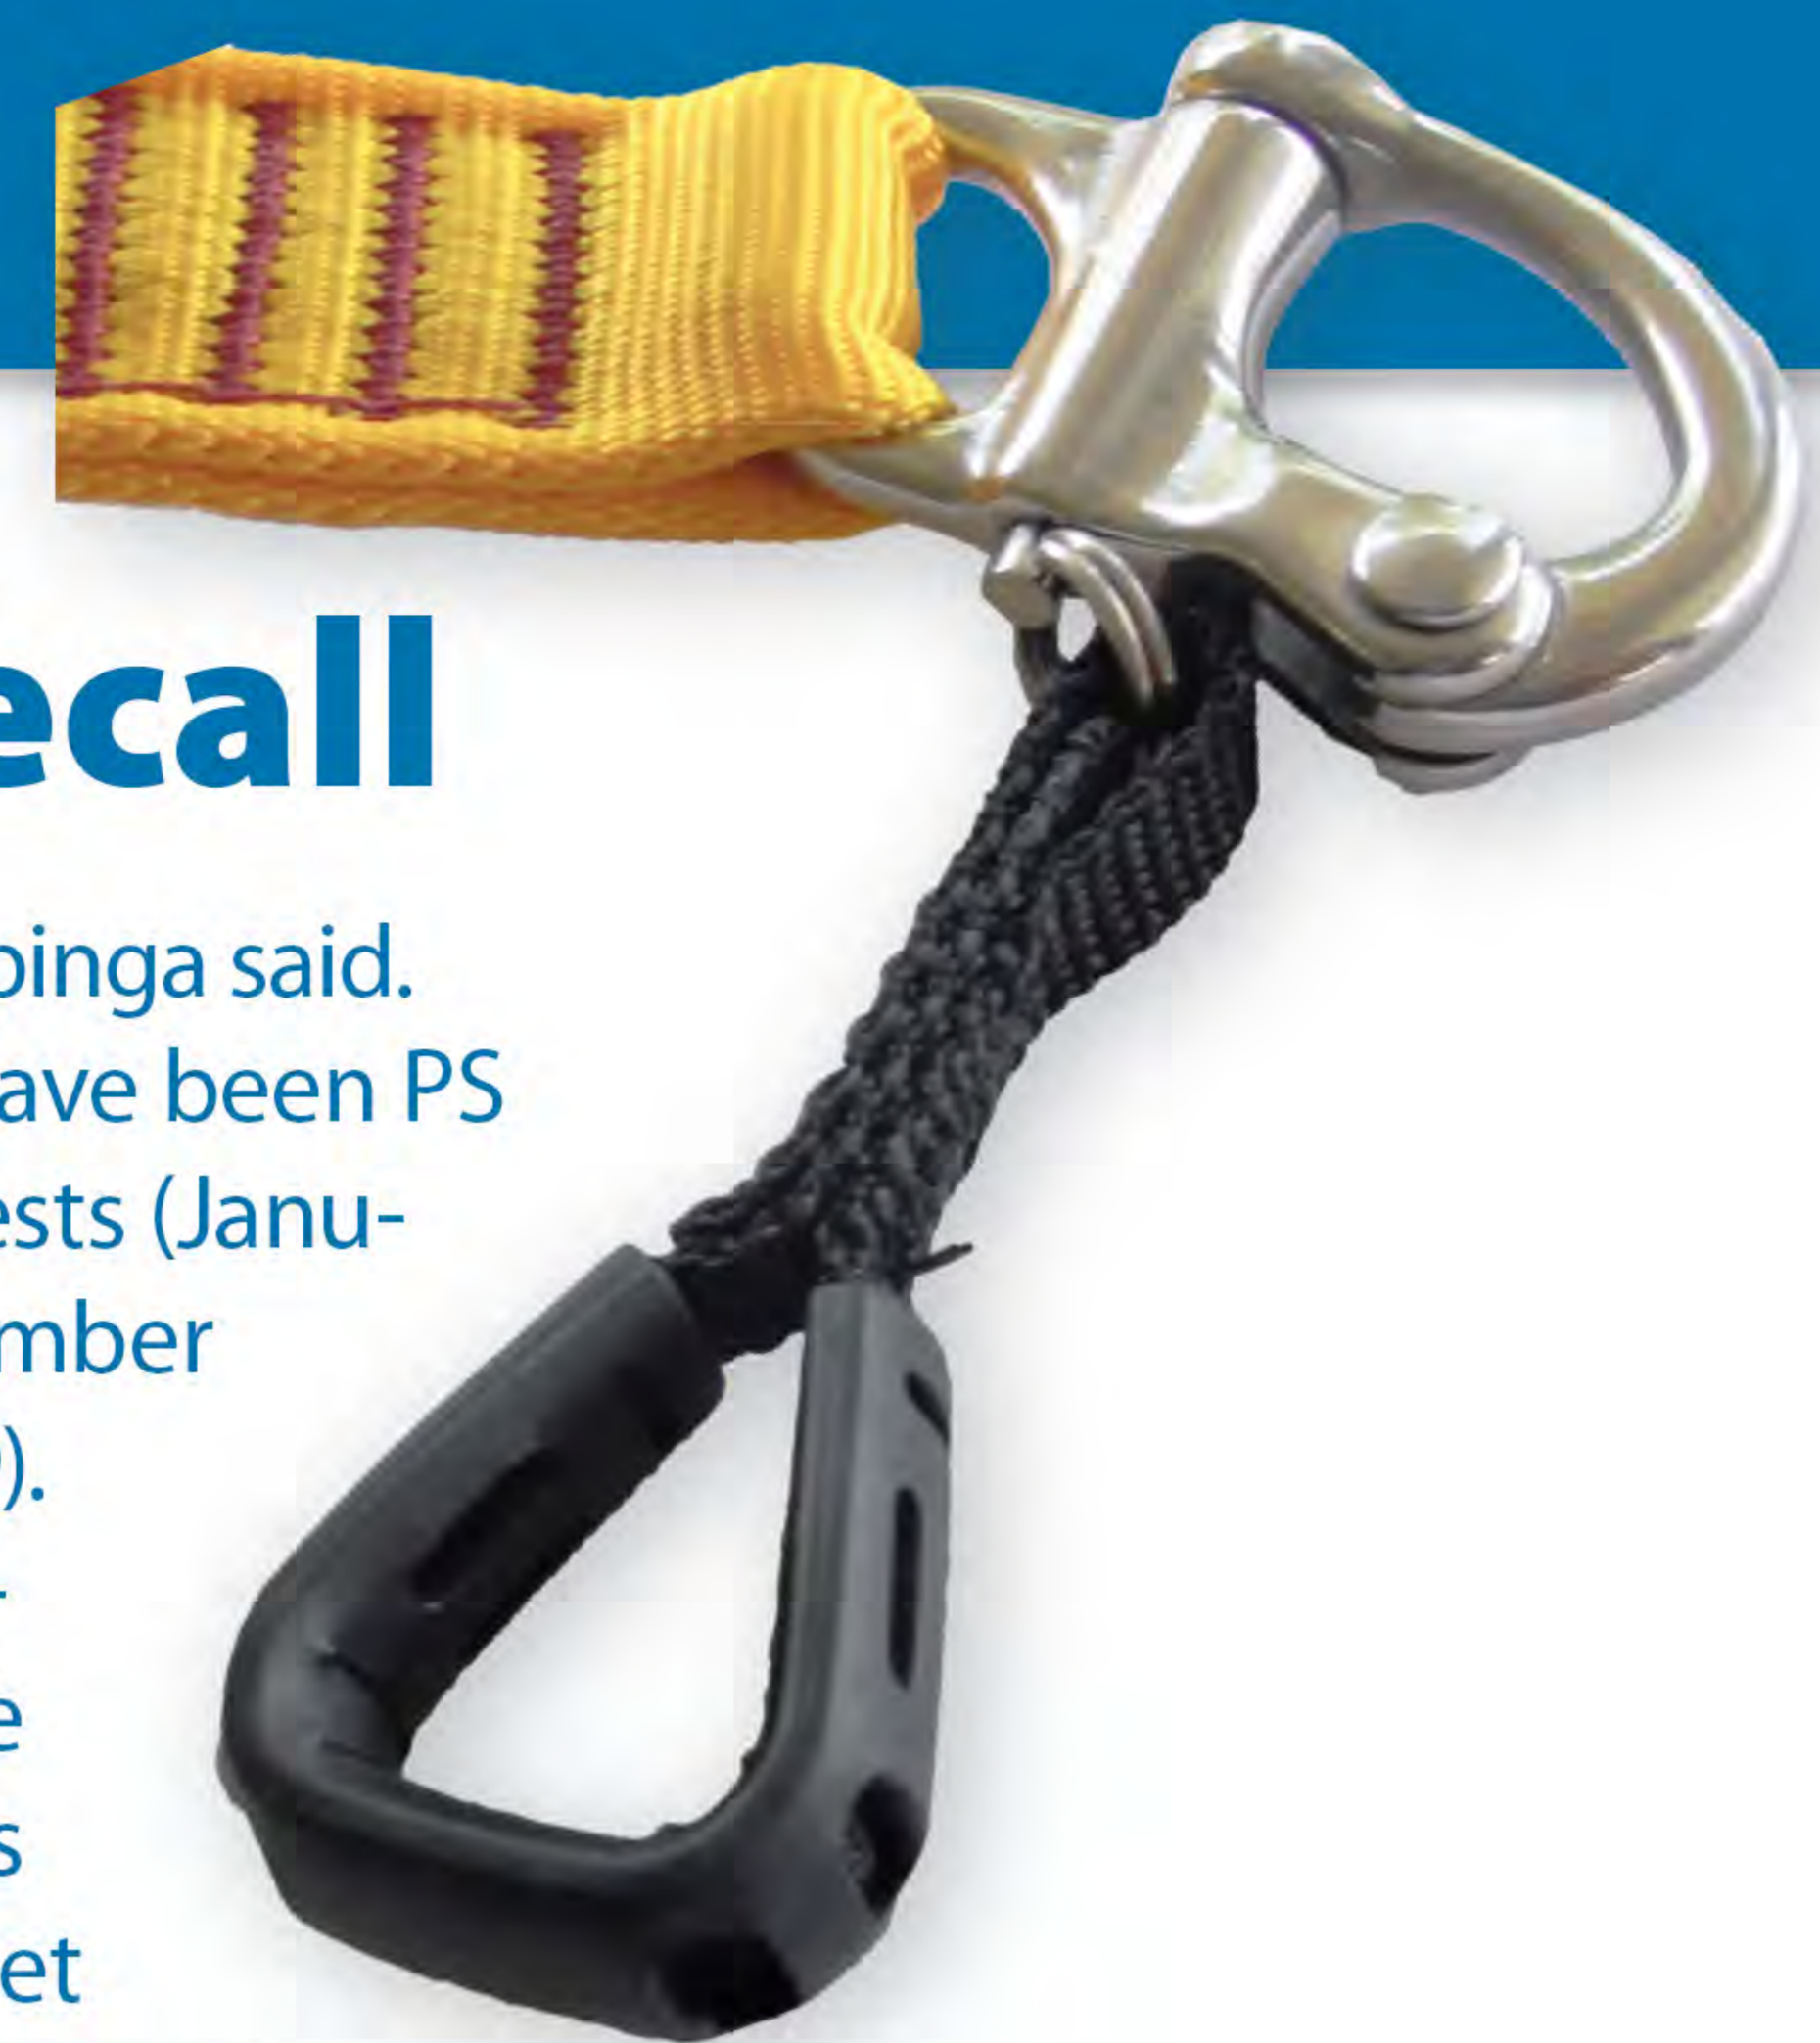
**P**ractical Sailor reader Mike Cunningham recently wrote us about a failure that occurred to his safety tether while he was going through a safety check of his gear. The tether features a quick-release snap shackle at the harness end and Kong hook at the boat end. (See photo.) His recounting of the failure follows:

"I found a serious problem with my tether with Kong hook, which is an otherwise excellent tether," wrote Cunningham, who sails a Freedom 30 out of Stockton, Calif. "The release grip is the triangular rubber type on a webbing lanyard. What is hard to see is that the lanyard is attached to the snap shackle pin with a split ring. While testing one of my tethers the other day, I found the snap shackle to be a bit sticky—as would certainly be the case after a few days at sea. When I pulled hard on the lanyard, the split ring elongated, deformed, and then simply opened up, leaving me with the lanyard in my hand and a snap shackle pin that had not moved even a little.

Japinga said that the company had alerted the appropriate regulatory agencies of the potential safety issue and that West Marine had traced the failure cause to an incorrectly sized split ring. New West Marine tethers will have a smaller diameter (12 millimeters) split ring than the older models. Customers who have a tether with the large split ring can return the product to West Marine for an upgraded model. More information is available at West Marine's website, [www.westmarine.com](http://www.westmarine.com).

There are several tether manufacturers that use the split ring like the one that failed in Cunningham's tether. If you already have a West Marine tether that looks suspect, you should return it to West Marine for an upgrade. The ring should sustain about 60-pounds of pull without deforming, the most force a person could reasonably apply using a finger pull. If it is not a West Marine tether, inspect it for proper functioning and if you suspect a potential problem, contact the maker or replace it.
