# CURING CORE PROBLEMS

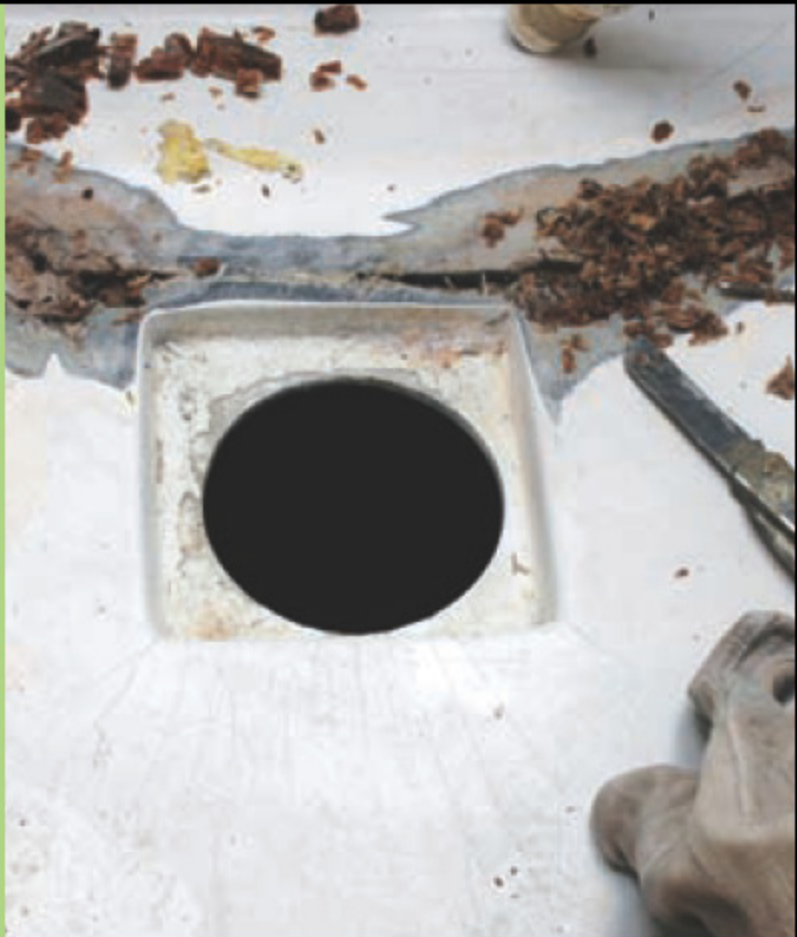
Core repairs range from straightforward DIY mini projects to remedies that require the removal and replacement of a good portion of the laminate and core. In the case of the spongy deteriorated cabin sole on a Cape Dory Typhoon (at right), the cure was straight forward. After probing the area to determine the extent of the damage, workers removed the rotted delaminated balsa core and flushed the area twice with denatured alcohol, then allowed it to air dry.

*Tell-tale crack signals core failure in the cabin sole of this Cape Dory Typhoon.*

The next step was to fill the void once occupied by core material with an epoxy resin thickened with micro-balloons to the consistency of thick peanut butter. West System 105 or Interlux Epiglass epoxy resin are good choices for such a job. Each manufacturer markets a medium density filler that can be mixed with the resin and loaded into a caulking gun type of cartridge that makes application quick and easy. Care should be taken not to force too much epoxy paste into the void because the pressure generated can cause further

core/laminate shear.

Once the filler has cured, the area was sanded with 50-grit paper to create a slightly dished out contour over the area where the cracks had occurred. Three or four layers of 10-ounce fiberglass tape were used to scarf together the tapered edges of the top laminate of the cabin sole. The stronger, higher density epoxy filler better resists flex and has kept the cracks from reappearing.
