Refit has Owners Singing the Saggy Headliner Blues

Pactical Sailor recently received a letter from reader Mike Joseph who had purchased a derelict 1991 Beneteau First 235 as a rehab project boat. The biggest repair the boat required was replacing its saggy headliner, a common ailment of many used boats, particularly Beneteaus of the same vintage. We thought we'd share Mike's story as other readers are likely facing the same do-it-yourself fix. The following is from Mike's letter to PS.

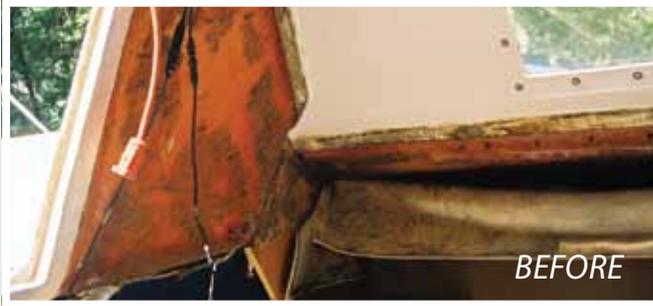
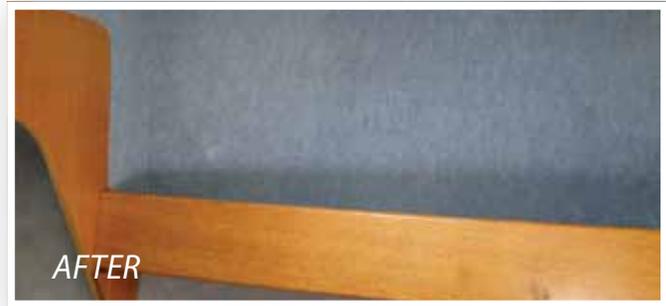
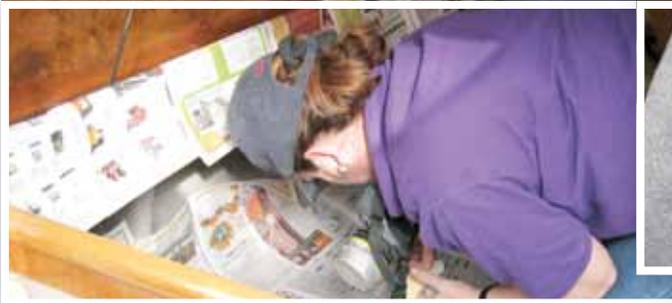
The crew protects adjacent surfaces with newspaper before spraying the adhesive for the carpet. Thin, flexible carpeting replaced the wornout vinyl headliner. Peregrine, a Beneteau First 235, sits on her mooring at Lake Giacomo, Mo.

Along with his first mate, Diann Holland, Mike spent several days scraping, sanding, and applying solvents (alcohol, acetone, and MEK) to remove the old liner and adhesive. He said the MEK did the trick, but warned that it'll dissolve the fiberglass if you leave it on too long. They used a fan to promote circulation while they worked in the cabin and also wore two-filter respirators.

After the crud was removed, the crew measured out the carpet panels, cutting them over size, then taping them in place and trimming to exact fit.

After protecting all other surfaces with newspaper, the team sprayed the fiberglass surfaces to be carpeted and the carpet back with 3M's Car Care General Trim Adhesive (Part 08088), which is available at auto parts stores. "Although it was messy and apt to get on damn near everything, it worked as advertised," Mike commented. "The trick was to line up the panels correctly; the pieces could be pulled away and re-positioned or stretched into place, but correct-the-first-time was best."
