Practical Sailor™

Resurrecting a Windlass

Should this rusty gear be salvaged or replaced?

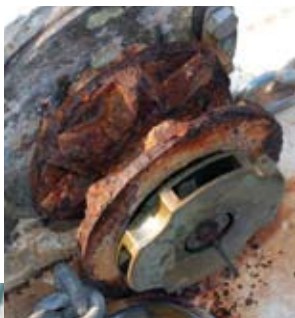
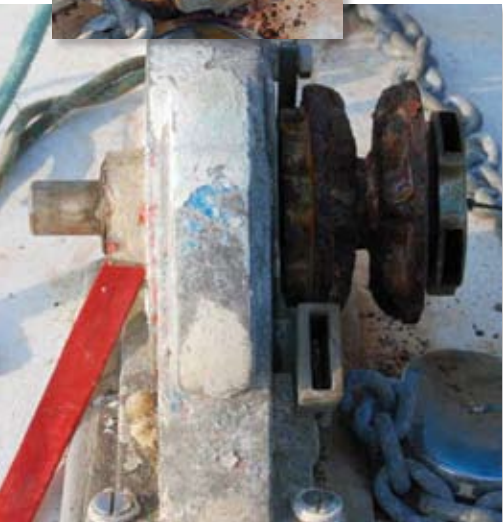
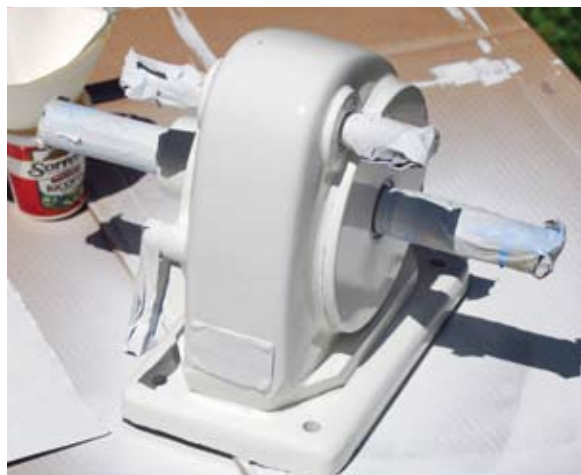
.....
Reader Gary Aitkin's anchor windlass gypsy is rusted beyond repair (far left, top and bottom). We suggest he search out a used Nilsson windlass like the one at immediate left, a rebuilt version of which we featured in a past issue.

on the shaft by a piece of wood in a quarter-inch slot where originally I presume there was a steel key.

The windlass in the pictures you sent is an old Simpson Lawrence, a British-engineered oddity that many owners cursed. They used a chain rather than a gear drive, and this led to problems. The cast-steel chain gypsy, aluminum case, and the chain issue make your windlass a less than prime candidate for rebuilding. We would recommend instead looking for a used manual Nilsson windlass.

The drum on the port side came off relatively easily after removing a bolt and fender washer, using a wheel puller. The drum was prevented from slipping
