Edson Steering Gear Upgrade

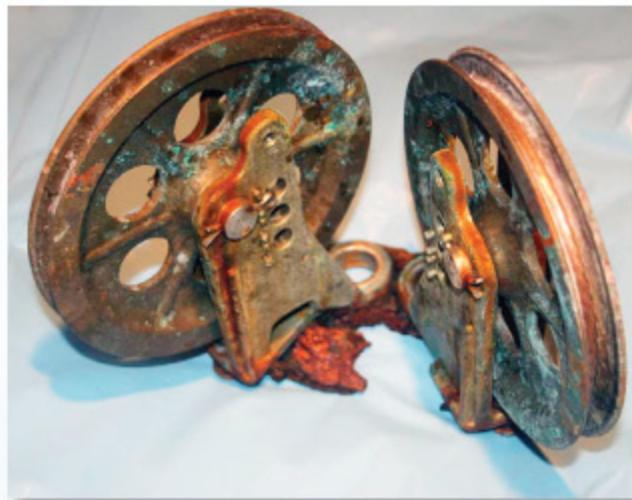
The problem turned out to be that the bronze idler pulleys at the base of the pedestal were mounted on a nice bronze bracket, which in turn was mounted on a flat steel backing plate.

Over the course of the last 15 years, the backing plate had completely corroded, as had the aluminum bolts that secured the pedestal to the backing plate. Given the inaccessibility of these systems under the

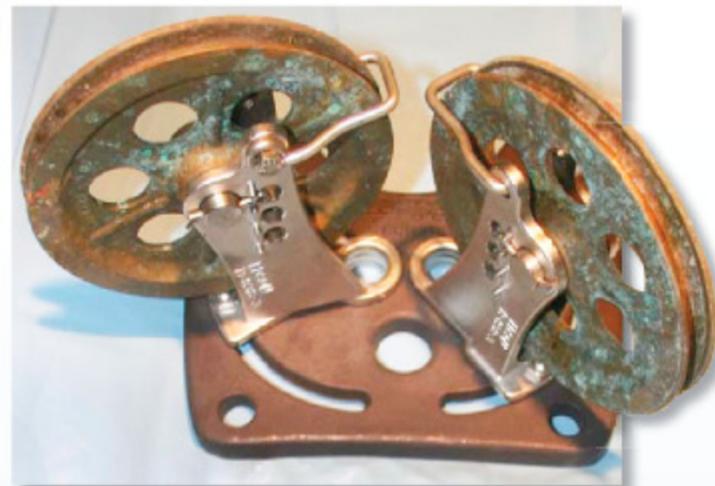
The original idler pulley assembly (left) on this Edson cable steering system succumbed to corrosion after 15 years. Edson now sells a replacement that has an aluminum backing plate instead of steel. Owners should inspect the cable and pulleys at least once each season.
