HOW WE TESTED

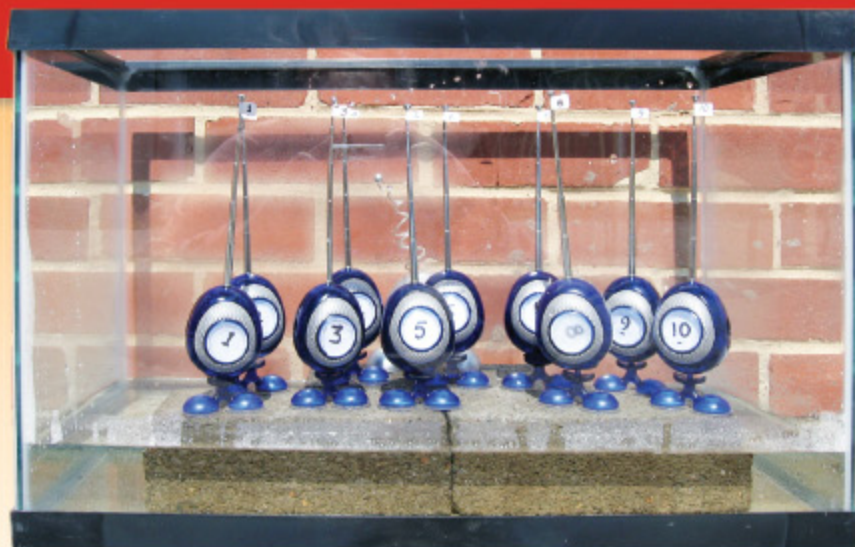
These cheap radios were sprayed with electrical protectants and then left to sweat it out in the humid atmosphere of an aquarium containing sea water.

After ensuring that each radio still worked, we placed them in a fish tank containing seawater, setting them atop bricks to keep them dry. Testers placed the tank in a sunny spot on a cement patio blocked from the wind, and in no time, the specimens were steaming in tropical heat—98°F and 93 percent humidity. We left the radios to simmer for 10 days, checking them every 24 hours.
