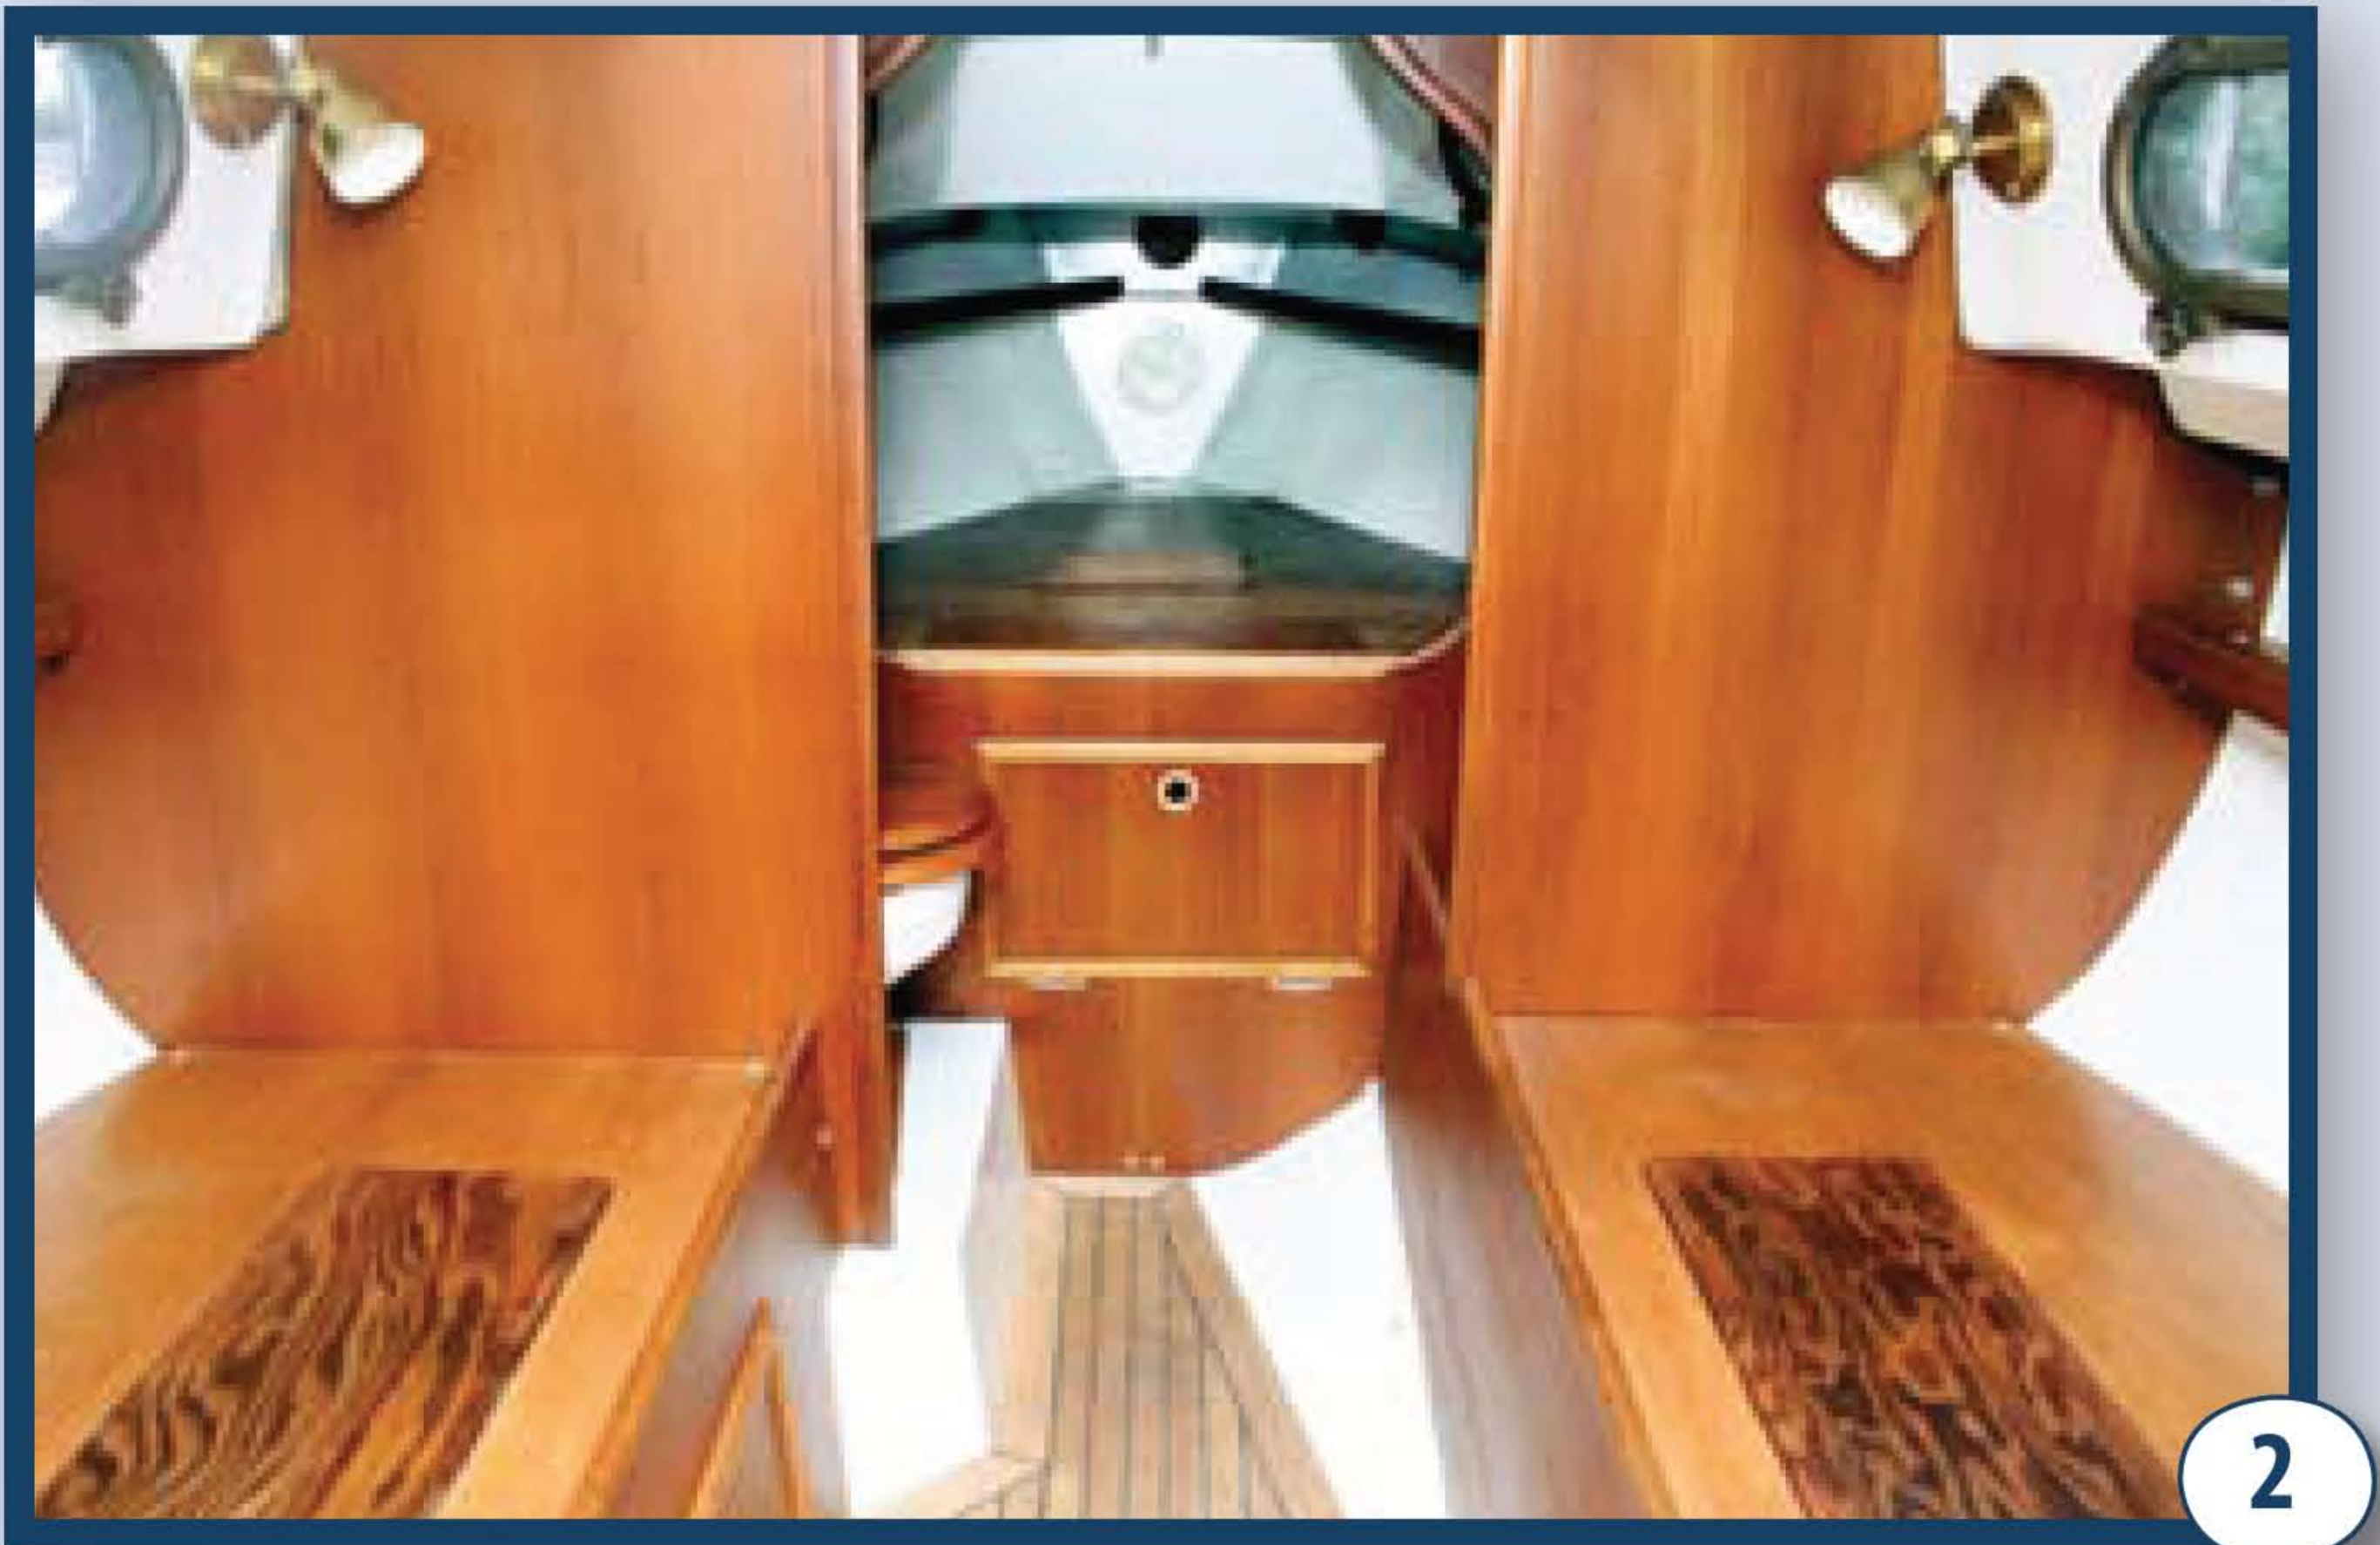
1. The forward view BEFORE; note the water-damaged bulkheads.
2. The forward view AFTER.
3. The head was re-plumbed to comply with California laws. A lockable, two-way Y-valve was added, as were a rigid holding tank, deck pumpout, and an above-the-waterline vented loop.

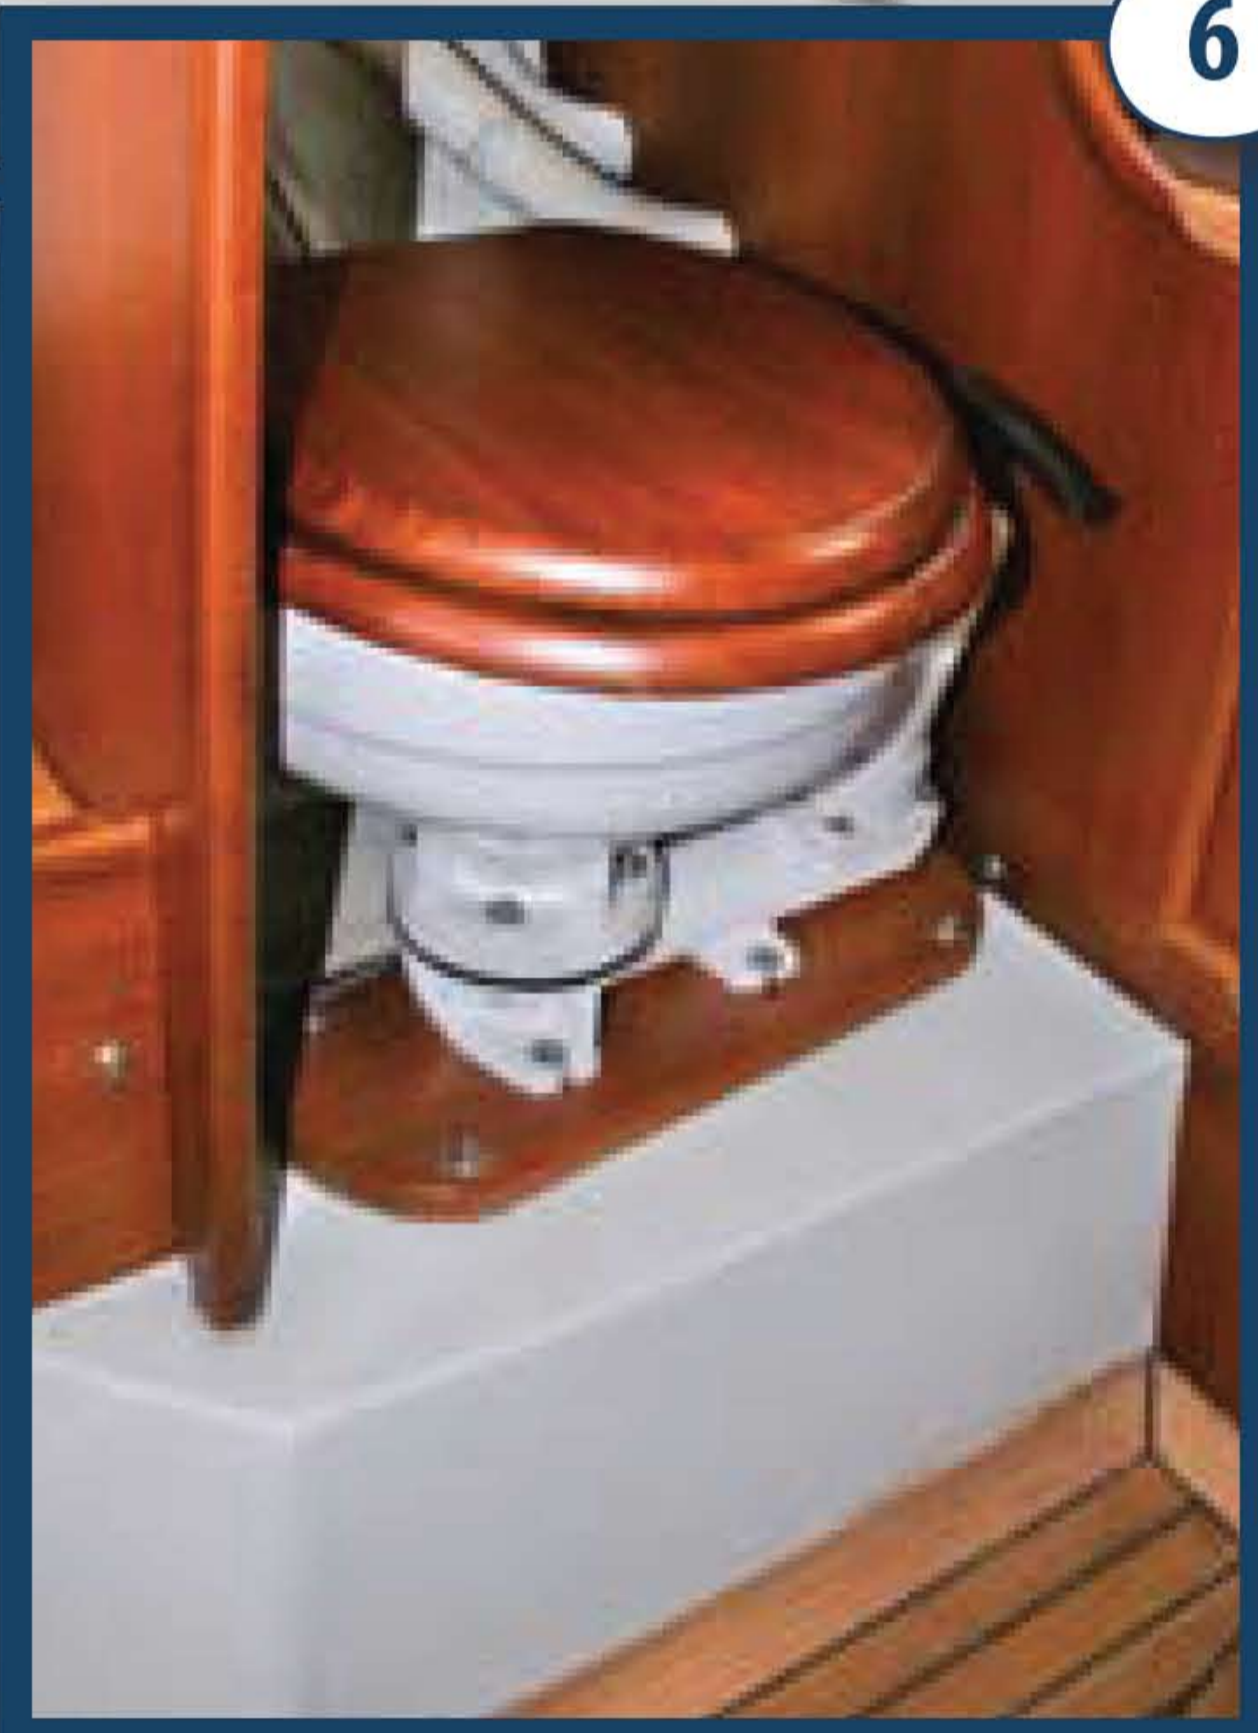
4. The aft view BEFORE.
5. The aft view AFTER. Among the projects still on the to-do list is installing the distribution panel.
6. Our favorite customization: the teak-topped throne.

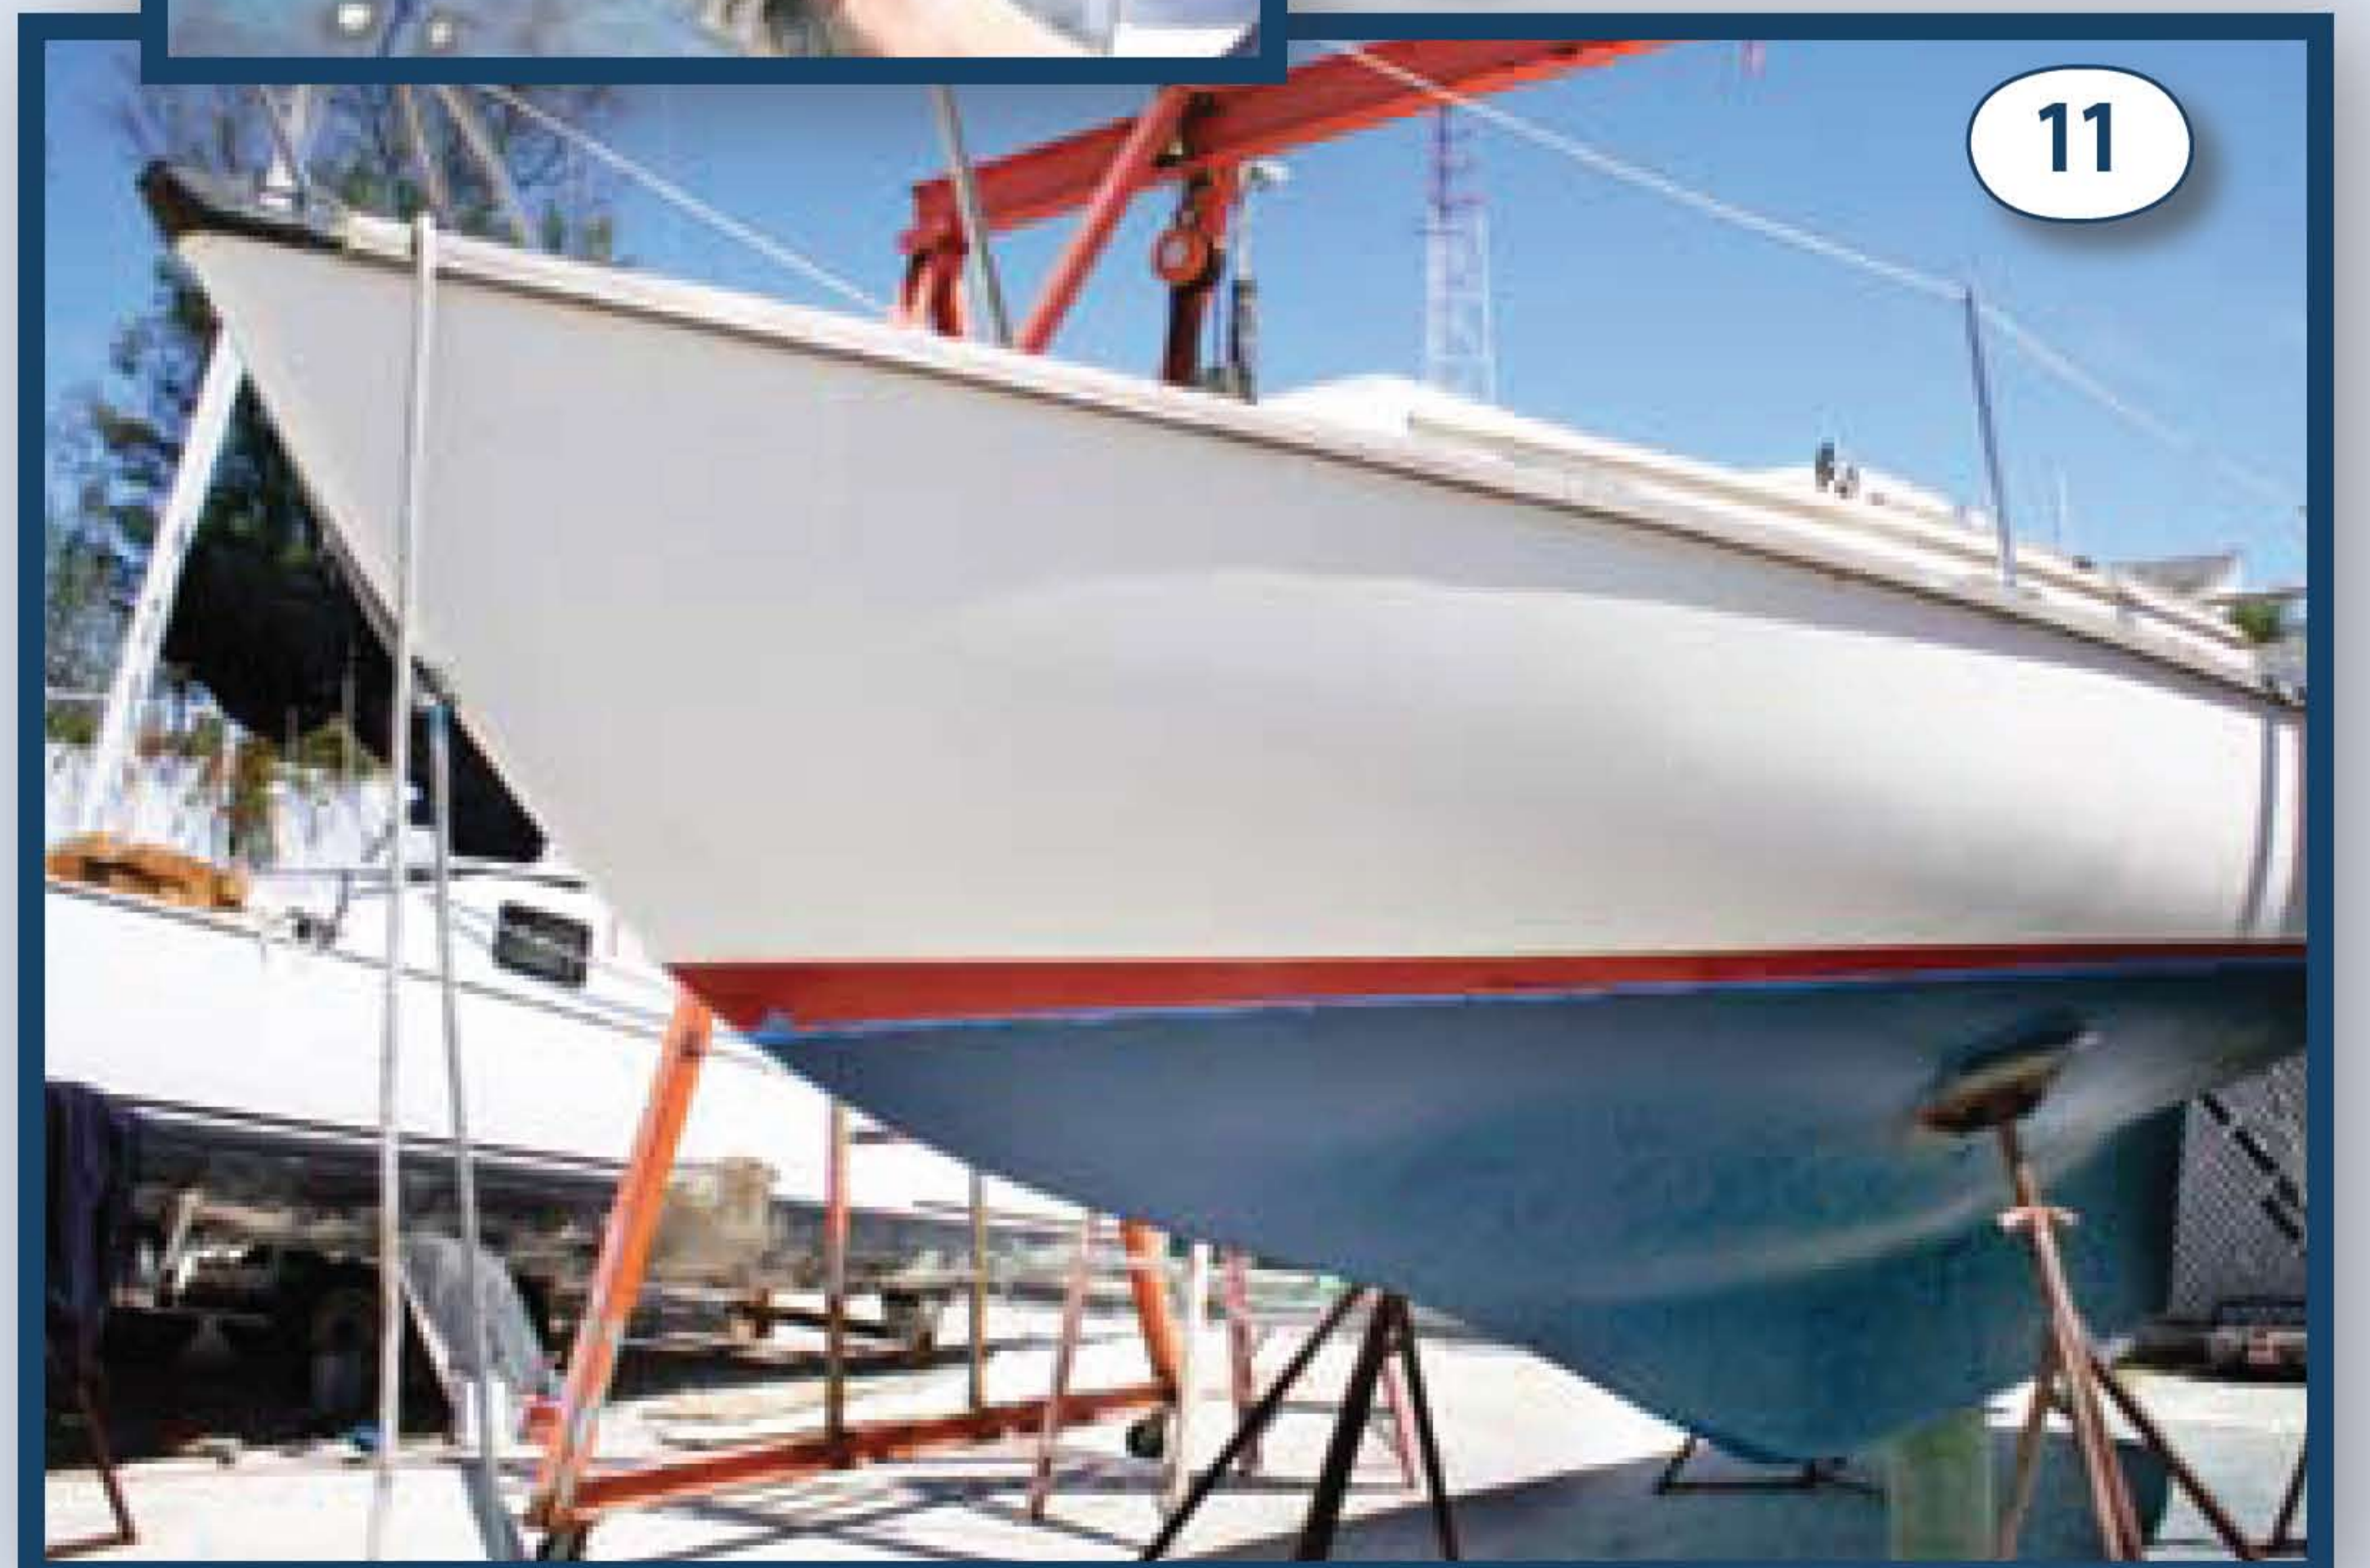
9. The spots where a previous owner had just painted over peeling antifouling had to be sanded to the fiberglass and faired.
10. A new cabin sole was constructed of 15 square feet of teak battens, Teakdecking Systems teak caulk, and phenolic backing, similar to a pre-fab teak deck.
