Fifty Ericson 41s were built between the years of 1967 and 1970. The design was eclipsed by the E-39 in 1972, and later by the E-38, both of which went on to earn their own loyal followers.

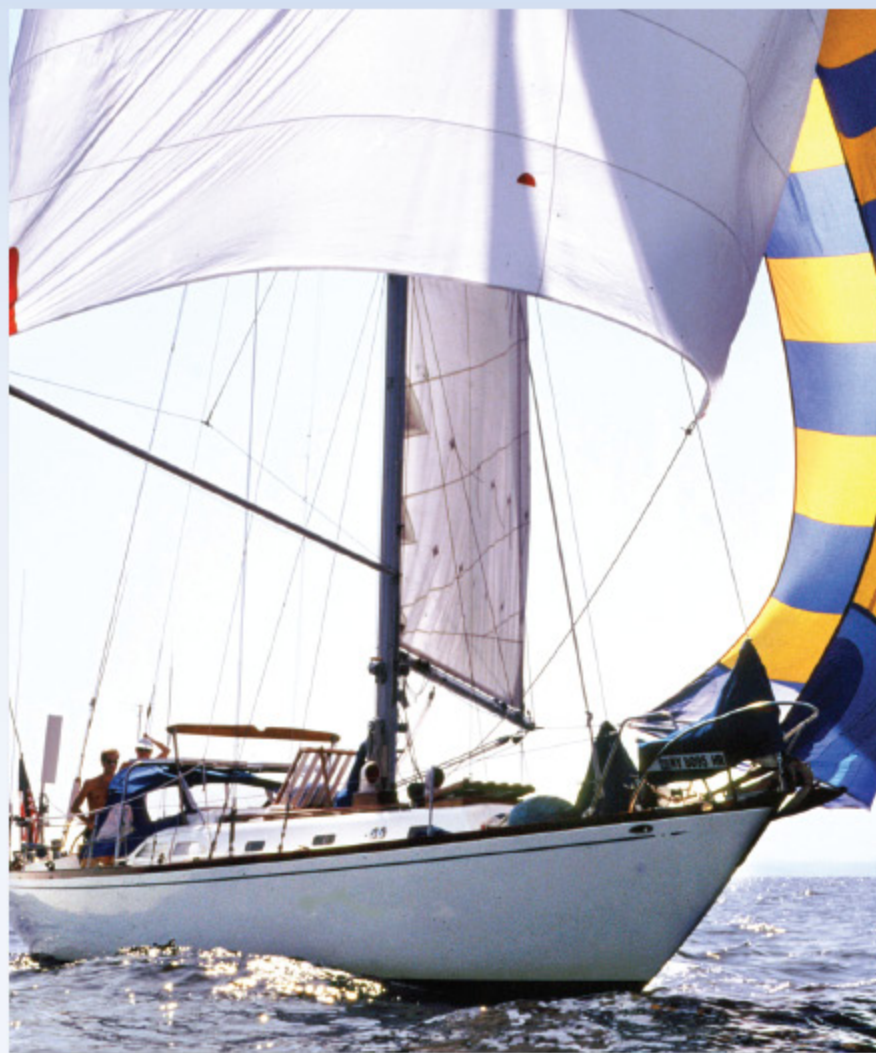
With the right sails, the robustly built Ericson 41 will still fare well in light winds.
