PS Urges End to Zippered Life Jacket Stowage Bags

In our recent move to a new larger PS workshop, we took a quick inventory of products still in long-term testing. As expected, a few items were dispatched to the Gear Graveyard, the final resting place for products that have fatal flaws or have reached the end of their life.

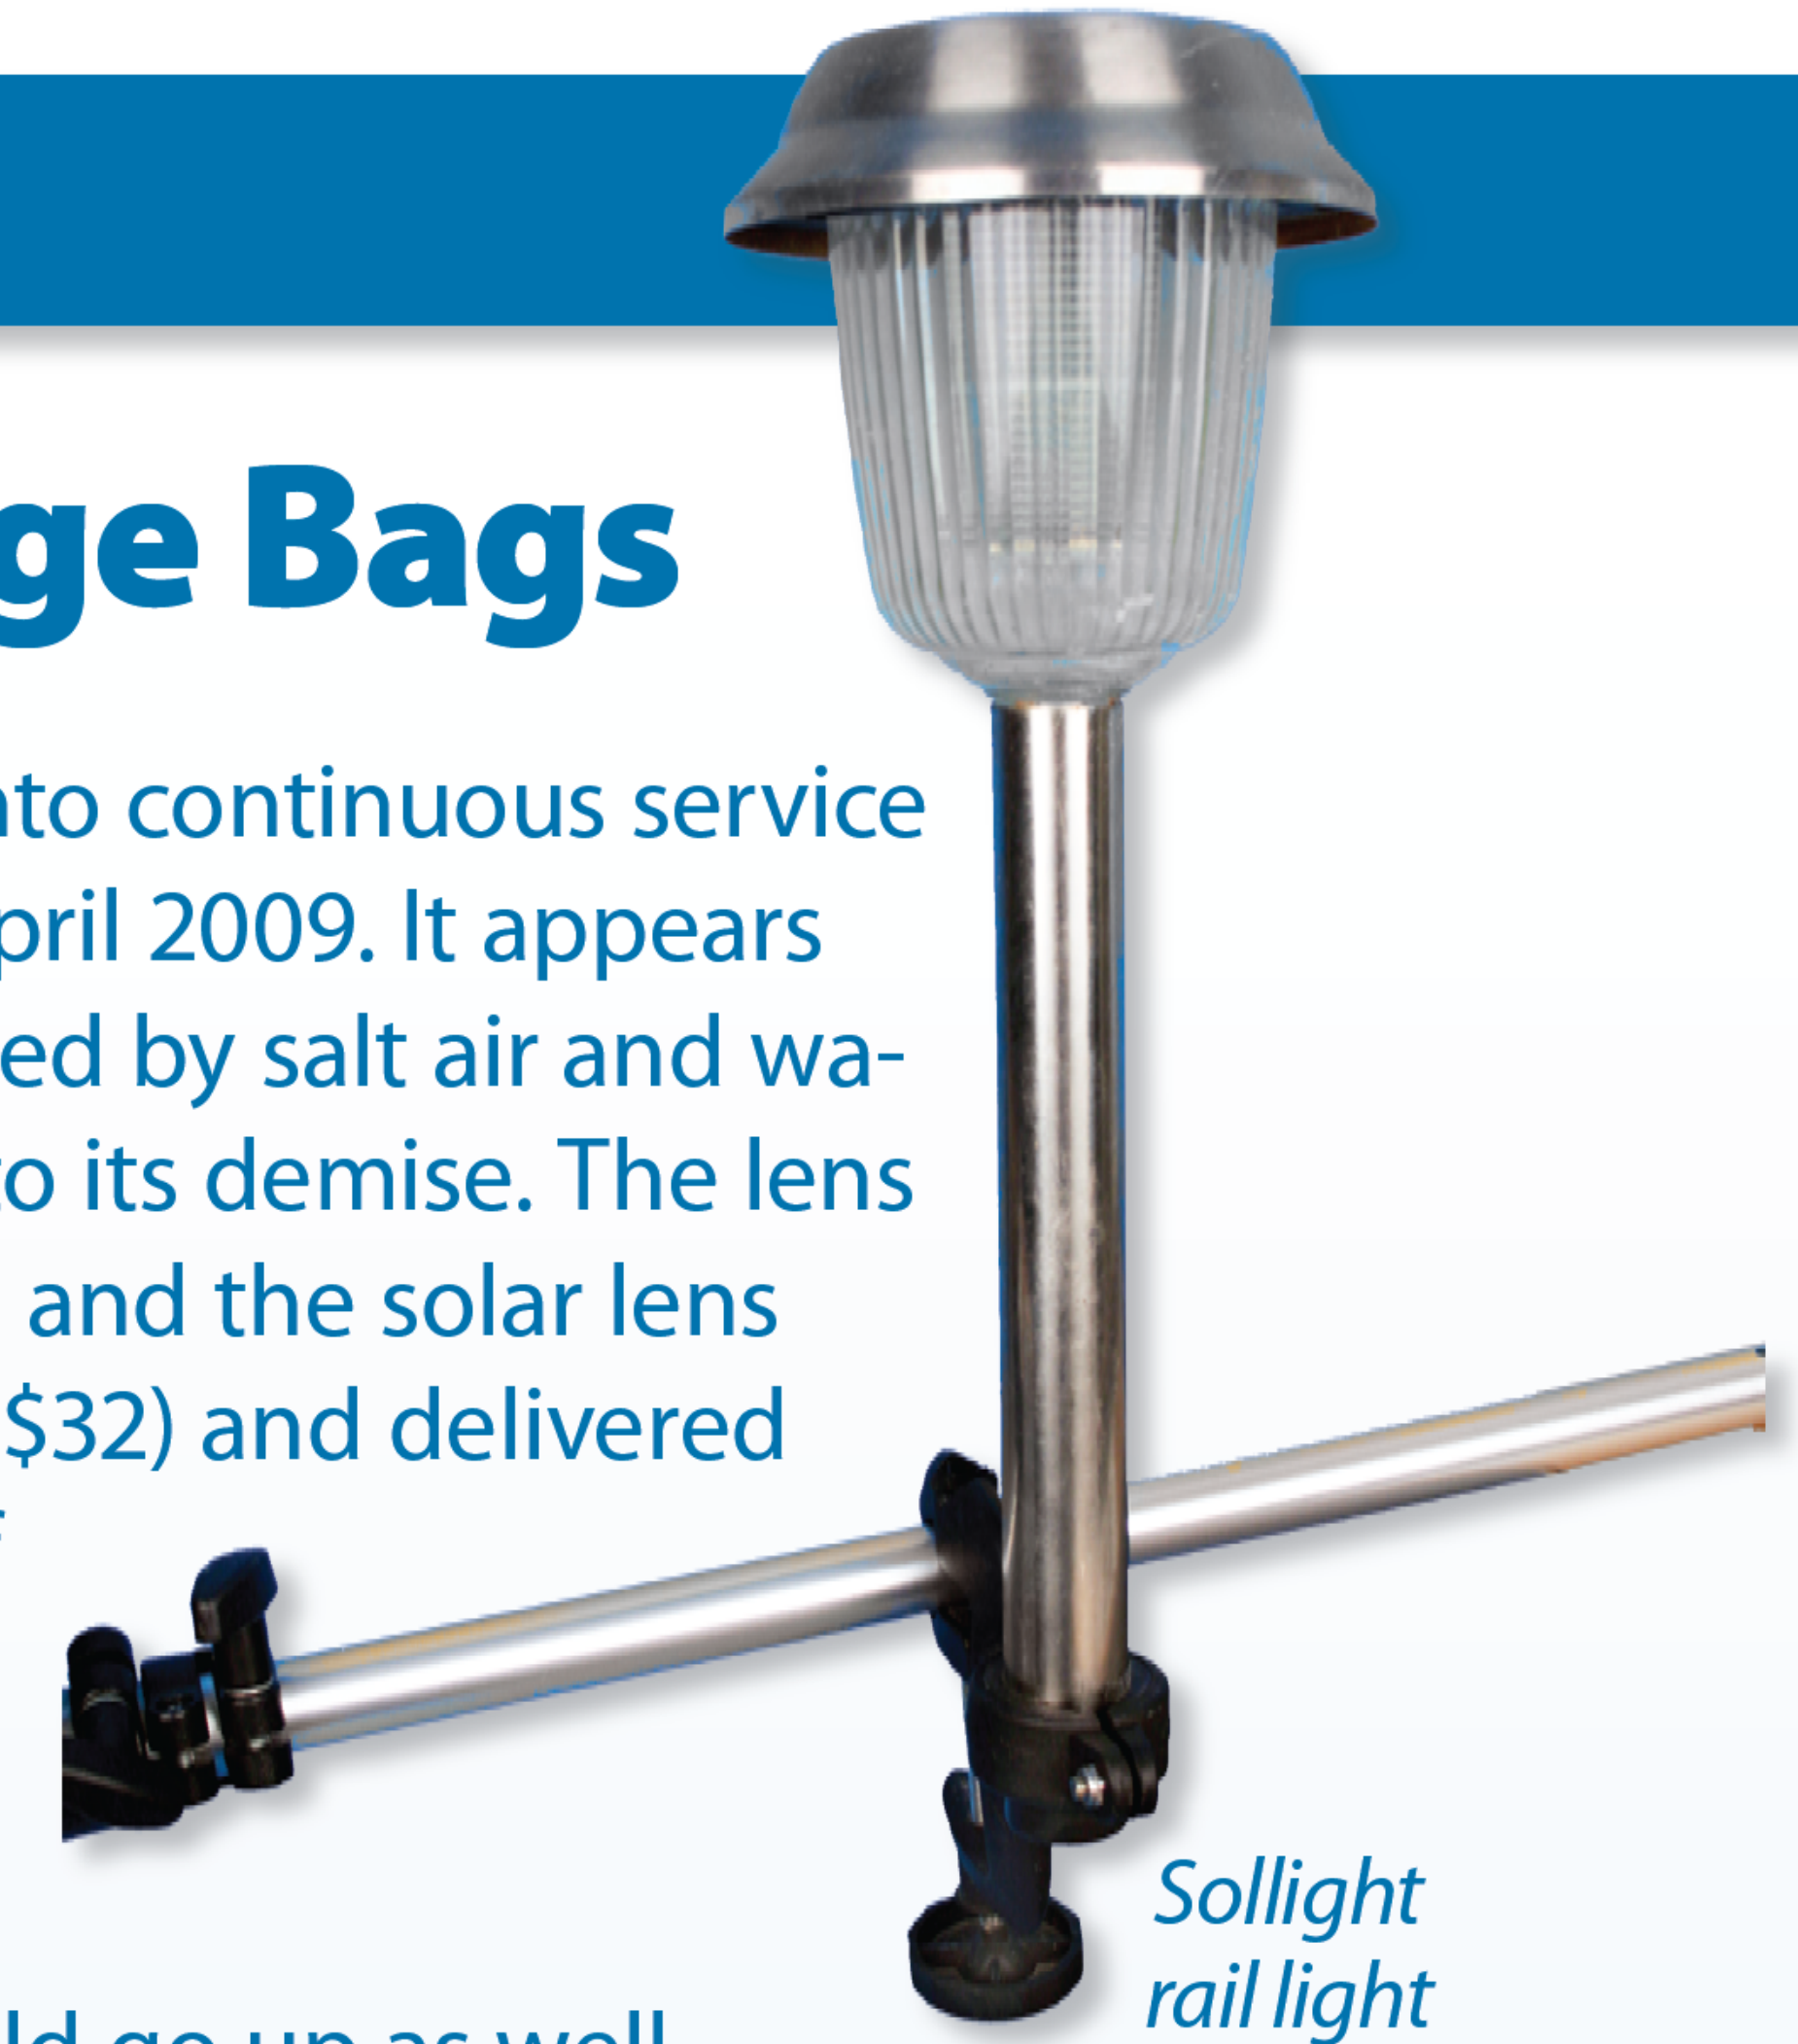
We weren't too surprised when our four-year-old rail light from Sollight (www.sollight.com) finally bit the dust. This

solar-powered light went into continuous service in late fall 2005. It died in April 2009. It appears that internal corrosion caused by salt air and water intrusion may have led to its demise. The lens is faded, the clamp wobbly, and the solar lens cloudy. It cost \$28 (now it's \$32) and delivered about five to eight hours of light per week for almost four years. Better engineering would add a few years to its life, but the price would go up as well. We couldn't expect much more for the price.

*Sollight
rail light*
