DIESEL TANK TROUBLE SPOTS

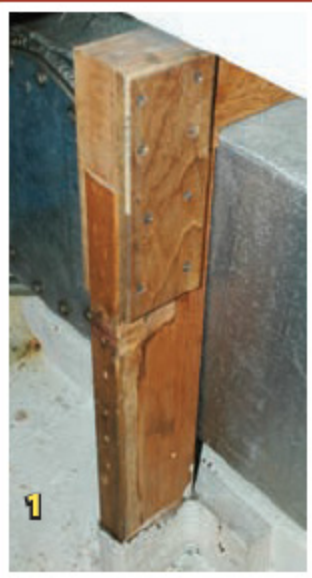
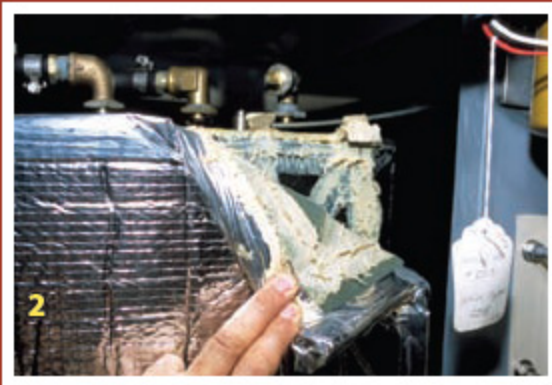
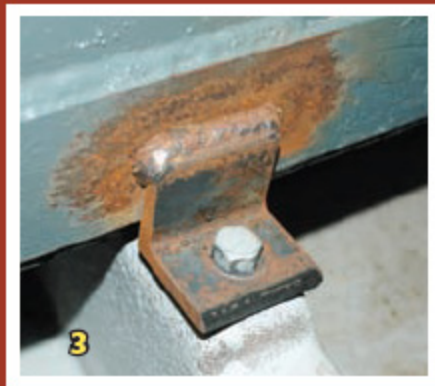
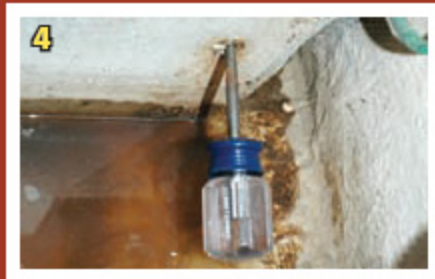
1. Direct contact between wood cribbing and the tank invites corrosion. **2.** Stick-on foam insulation traps moisture. **3.** Uncoated mild steel will corrode quickly. **4.** Placing a tank where bilge water sits accelerates corrosion.
