## DIESEL TANK TROUBLE SPOTS

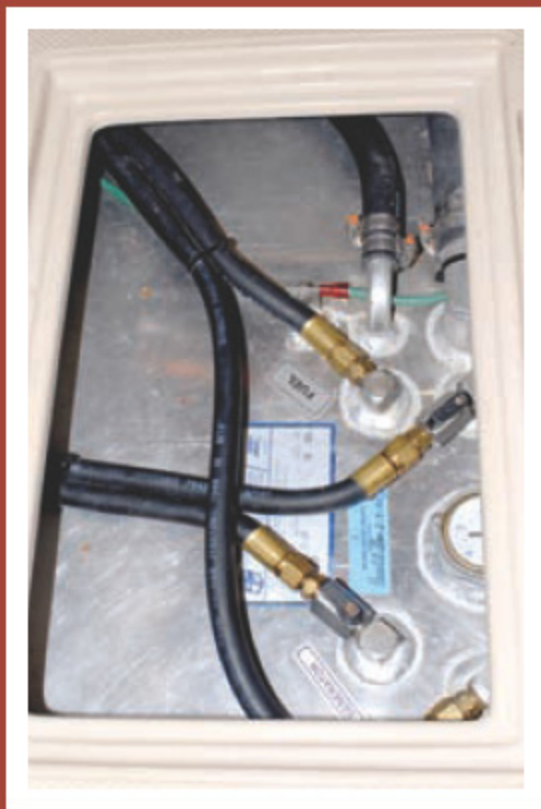
*Permanently welded fittings (left, top of photo) limit your options should the welding crack. Black iron tanks (below) are strong and cheap, but prone to corrosion. A deck leak at the fill pipe attacked this tank.*
